STATE OF NEW YORK DEPARTMENT OF HEALTH

FATALITY ASSESSMENT AND CONTROL EVALUATION

Contractor Run Over by Front-end Loader at City Salt Stockyard Case Report: 04NY002

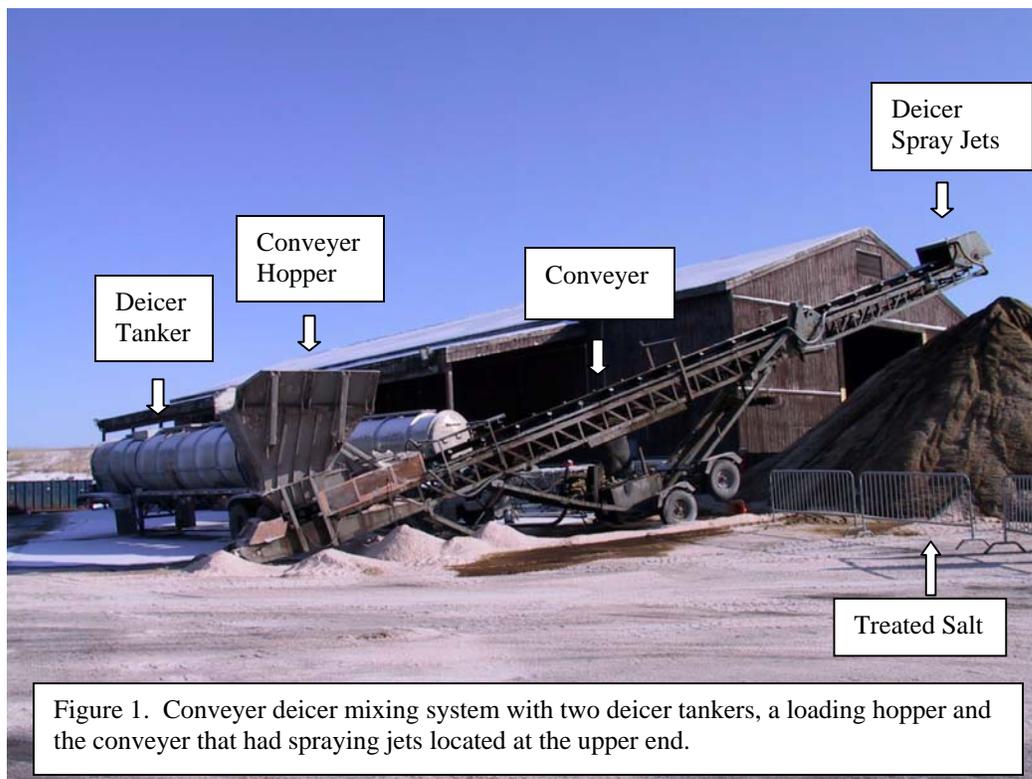
The stacking conveyer (Figure 1) was capable of processing approximately 300 tons of salt per hour. The mixing system had a set of six jets located at the top of the conveyer. The deicer was injected through the jets and sprayed onto the salt right before the salt fell off the belt. The conveyer mixer was equipped with a filtration system that was designed to prevent the jets from clogging up. The controls of the mixing system were located at the north side of the conveyer (Appendix A). When operating the conveyer, the victim stood between the deicer tankers and the conveyer where there was no loader traffic. However, according to the EOs, the spray jets kept clogging that day and the victim had to walk around the salt piles and enter the loader working area to perform maintenance.

Recommendation #8: *Distributing companies should modify equipment to reduce maintenance during operation so operators can avoid entering loader working areas.*

Discussion: On the day of the incident, the deicer spray jets that were located on top of the conveyer clogged numerous times and the victim had to perform frequent maintenance that required him to walk in an area with busy loader traffic. The victim was witnessed working on the spraying jets while the conveyer was running. The conveyer mixing system should be evaluated and the following should be considered if feasible:

- 1) Improve the filtering system to prevent the jets from clogging;
- 2) Relocate the jets so that they are easier to access from an area without loader traffic; and
- 3) Install remote controls so operators can turn off equipment while testing and working on the spray jets.

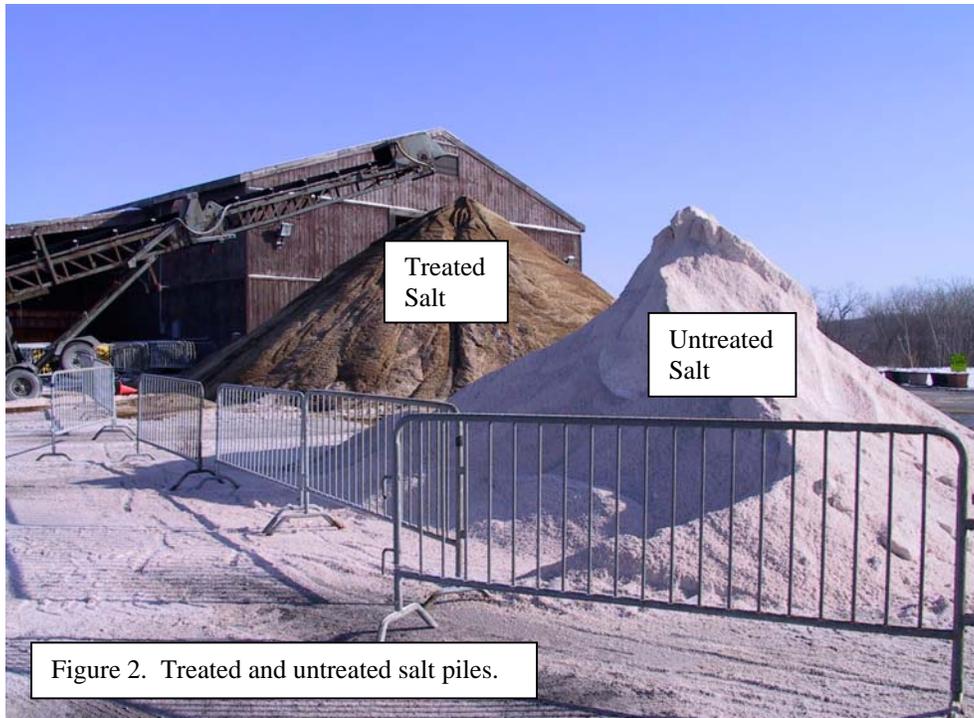
On the day of the incident, the victim wore an earth-tone Carhart suit and a dark blue canvas jacket; he was not wearing a high visibility safety vest. He also wore a hat and a pair of wrap-around safety glasses. In order to communicate with the EOs, who had two-way radios to communicate within the cabs, the victim had to catch the EOs' attention by gesturing or making eye contact. Witnesses reported seeing the victim walking in the areas between the two salt piles, behind the loaders, and near the salt shed entrance numerous times. According to the EOs, at least four times during that day, the victim climbed up to the top of the 25-foot high treated salt pile (Figures 1 and 2) to clear the clogged jets with a wire while the conveyer was running.

Recommendation #4: *DGS facilities should develop and enforce a policy that requires all employees and on-site contractors to wear high visibility safety vests.*

Discussion: High visibility safety vests are much easier to spot than tan or dark red uniforms in the earth-colored background of the treated salt pile. The DGS should require that all employees and on-site contractors wear high visibility safety vests while working in the salt yard.

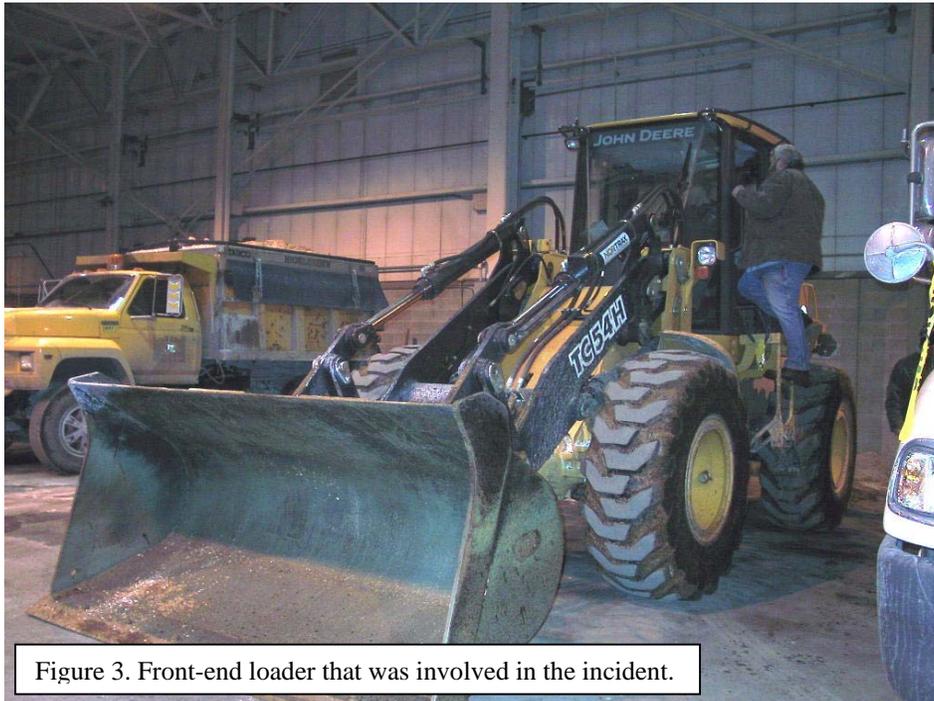
Figure 3. Front-end loader that was involved in the incident.

Operator A used a 2003 John Deere TC 54H wheel loader (Figure 3) that had been purchased by the DGS the previous year. The articulated four-wheel drive loader weighed about thirteen tons. It was equipped with an audible backup alarm and strobe lights that flashed during backing. At the time of the incident, both the audible alarm and the strobe lights were working properly. The loader had a right rearview mirror inside the cabin, and originally had exterior side-rear view mirrors on both sides. The two exterior mirrors had been broken off by tree branches during a snowstorm in December 2003 and had not been replaced. On the right side, the operator had virtually no blind spot due to a right interior rear view mirror. However, with the left exterior mirror missing, the

operator's blind spot on the left side extended back from the left rear of the vehicle approximately nine feet.

Discussion: If a piece of equipment becomes damaged or malfunctions, it should be removed from service until it is repaired. In this case the rear view mirrors that were broken off during a December snowstorm were not replaced until January 23rd, ten days after the incident. Although the missing mirrors in this case may or may not have directly contributed to the incident, they did create a blind spot for the driver on the left side of the vehicle.

Recommendation #2: *DGS facilities should repair damaged equipment in a timely manner.*

Recommendation #3: *DGS facilities should consider installing additional backup safety devices on heavy equipment to warn operators when someone is in their blind spot.*

Discussion: In a busy work zone like the salt yard, workers often work in close proximity to moving heavy equipment. Being exposed on a daily basis to the noise and warning devices of backing equipment can desensitize individuals to the presence of such vehicles. There are devices available that can detect the presence of persons in the blind spots of vehicles and warn the driver. Readily available backup safety devices include: video cameras that can be mounted on the vehicles and sensor systems using ultrasonic or microwave energy to detect objects within a preset distance behind the vehicle and alert the driver. These additions should be considered especially when the standard practice has failed.

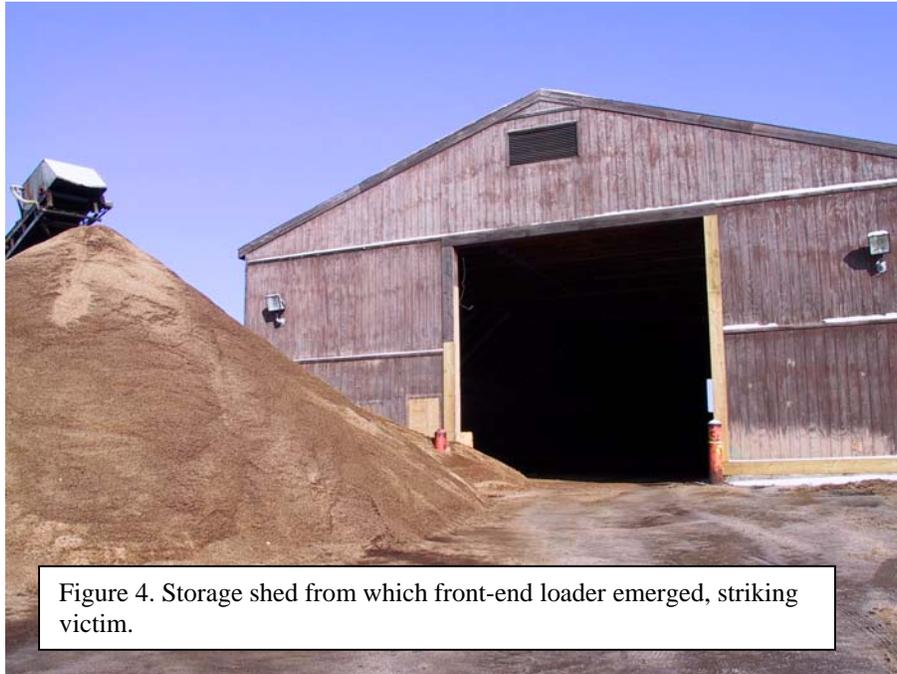
Figure 4. Storage shed from which front-end loader emerged, striking victim.

When Operator A began working at the salt yard at approximately 3:00 p.m., the area in front of the entrance and two-thirds of the shed entrance, which was approximately 20 feet wide, were piled with treated salt. The salt pile in the pathway of the loader created a potential roll-over concern. Operator A tried to shave some of the salt off the salt pile and clear the entrance area. He backed the loader out of the shed (Figure 4), stopped the loader, set the bucket facing the shed entrance, scooped up the salt on the path, drove to the shed, and dumped the salt, then backed out again to pick up another load.

standing between the two salt piles. Operator A asked the victim to set the conveyer out-feed end further away from the shed entrance in the future so the treated salt would not obstruct the path of the loaders. After talking to the victim, Operator A watched the victim walk toward the conveyer. Operator A then started his loader to continue transporting the salt. According to the operator's estimation, he did three more runs before the incident occurred.

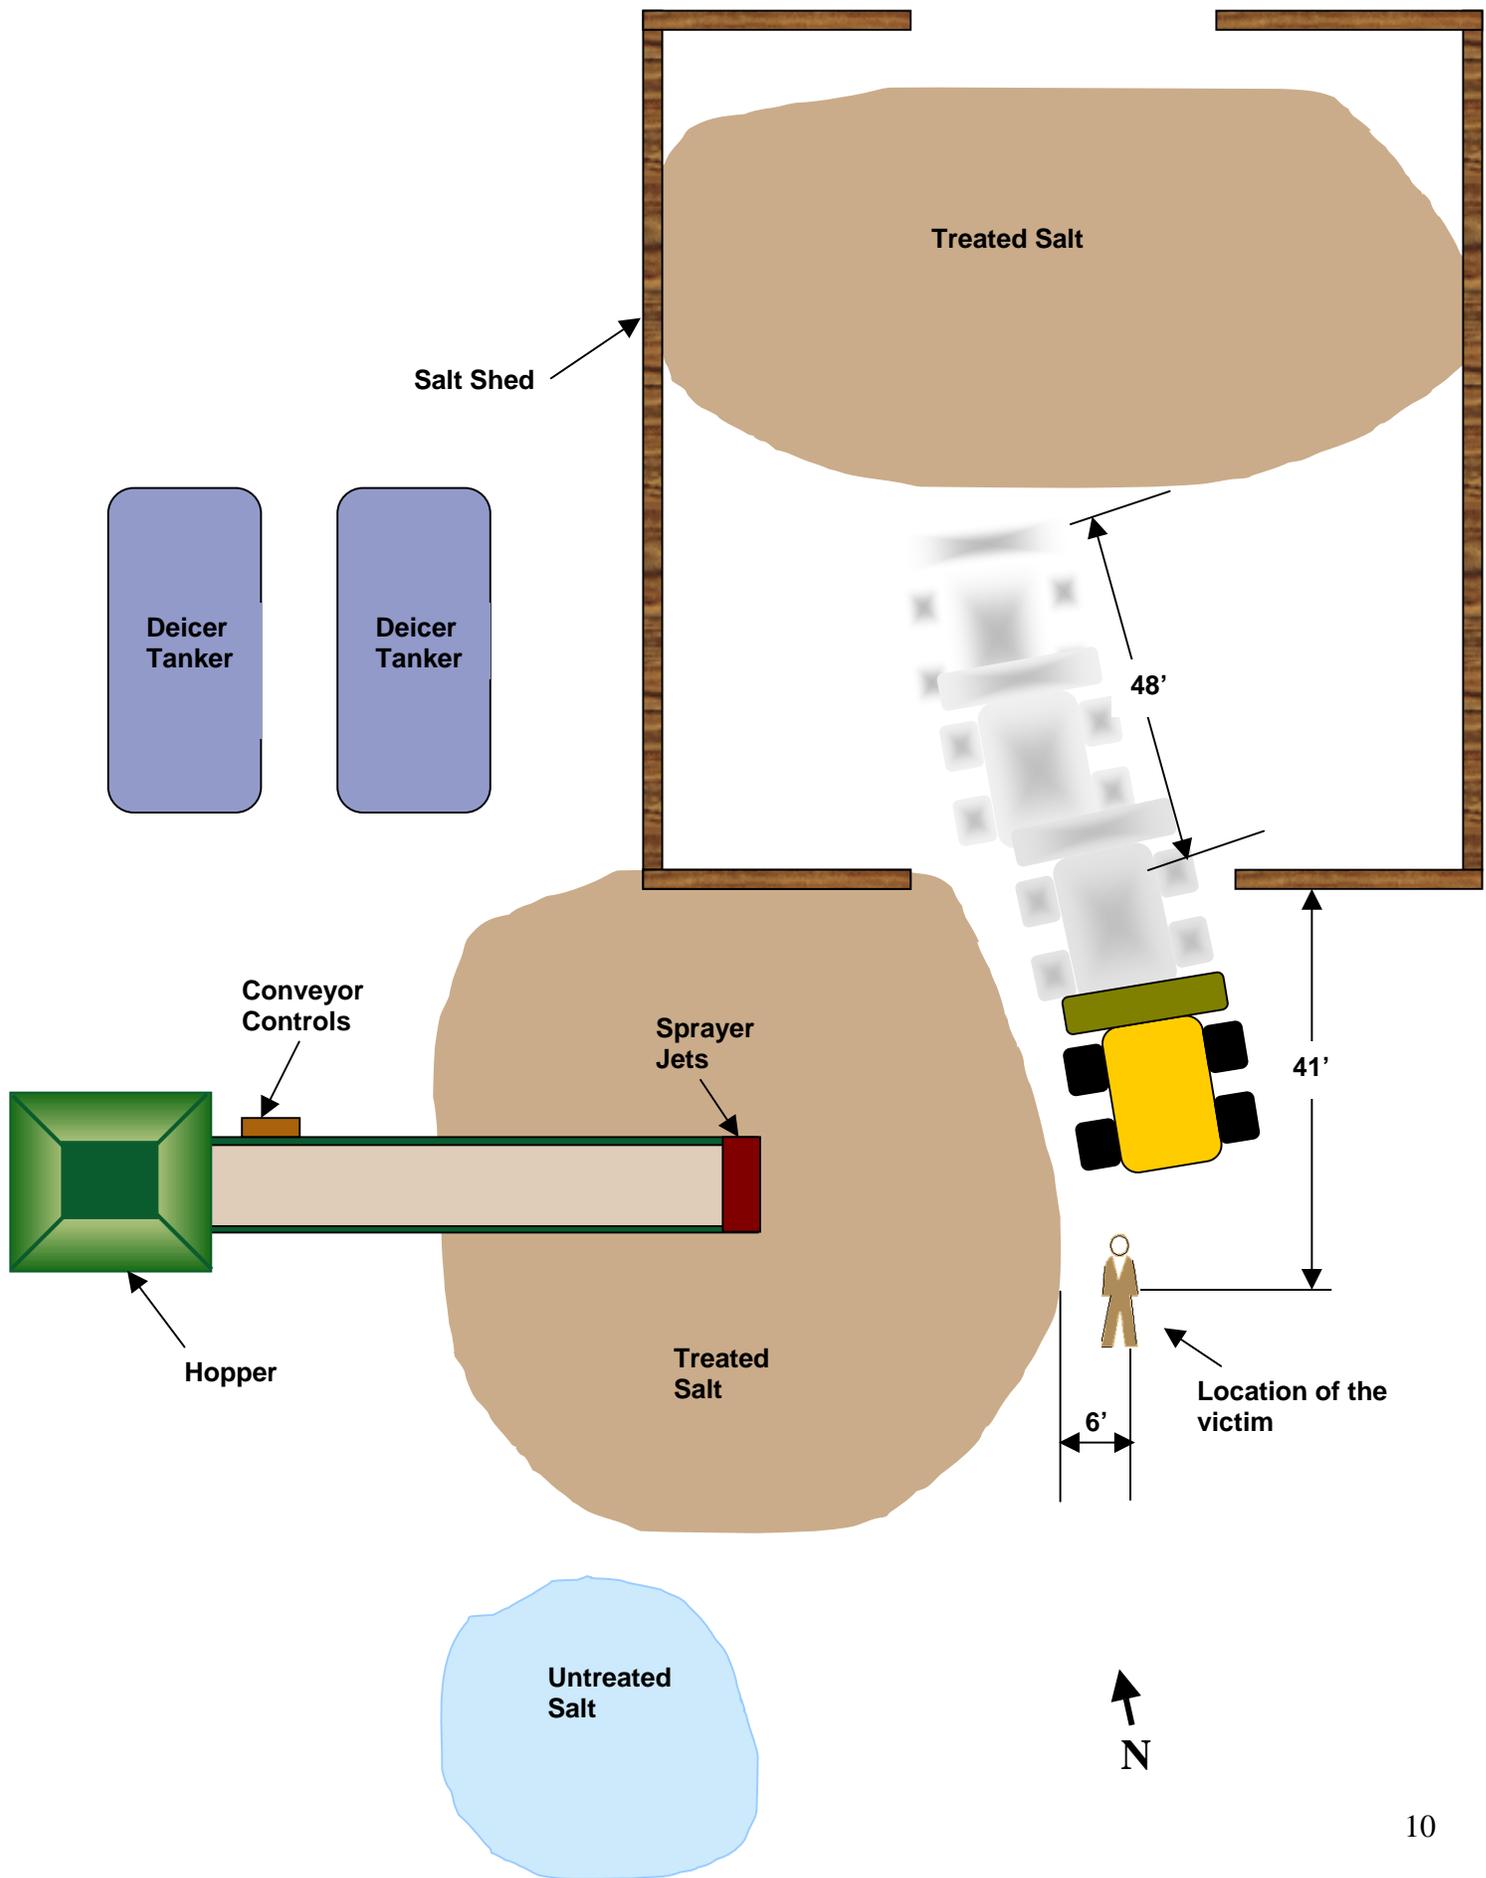
Appendix A. Diagram of Incident

Just prior to the incident, one EO was working at the in-feed end of the mixer and another was fueling his loader at a gas pump at the other end of the salt yard. Neither of these EOs saw the incident. At approximately 3:50 p.m., Operator A began backing his loader out of the shed after dumping a load of salt (Appendix A). The loader backed 48 feet inside the shed to the shed entrance and then proceeded to back 41 feet outside the shed. Operator A stated that he looked back, left and right before and during backing, but did not see the victim in his path. As he backed along the side of the salt pile, Operator A felt the loader rocking as if it had run over a pile of salt. Realizing that he had just cleared the area and there should not have been any obstruction, Operator A immediately stopped the loader. He looked down at the left side and saw the victim's legs under the left front tire. It appeared that the victim was struck from behind while he was walking south around the treated salt pile. Operator A pulled the loader forward to get the front tire off the victim, set the brake on the loader, got out and called 911 on his cell phone immediately. He then ran to the other two operators to draw their attention. Both operators jumped out of their loaders, ran to the victim and stayed with him. EMT arrived on the scene within five minutes. The victim was transported to a local hospital where he was pronounced dead.
