FATALITY ASSESSMENT AND CONTROL EVALUATION

Truck Driver Run Over by Trash Compactor at Municipal Landfill
Case Report: 02NY007

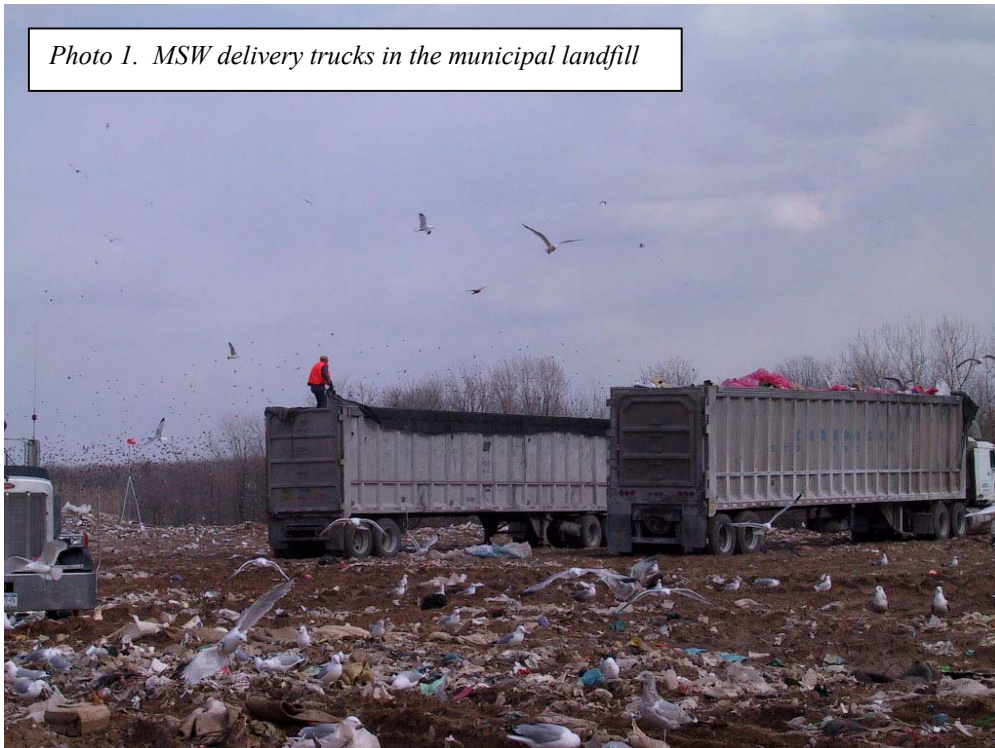
The MSW trucking company that employed the victim was located approximately 180 miles east of the landfill. The trucking company had 35 semi-trucks and employed 40 workers and 35 sub-contractors delivering waste from local transfer stations to landfills (Photo 1). This was the first fatality the trucking company had since beginning business 15 years ago. The decedent was a licensed commercial truck driver and had been employed by this trucking company for five years. At the time of the FACE investigation, the trucking company did not have a full time safety person, nor had it developed a comprehensive health and safety program. The trucking company provided the drivers with high visibility orange vests, but did not require them to be worn.

Photo 1. MSW delivery trucks in the municipal landfill

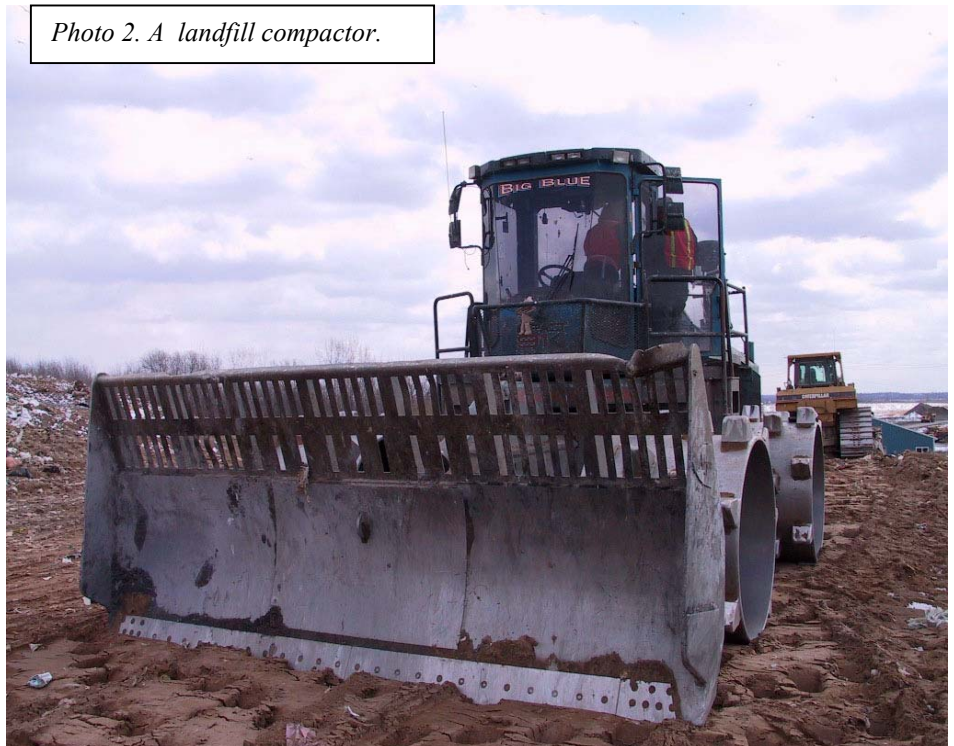
Each landfill compactor used at the time of the incident was about 30 feet long and 15 feet wide and weighed about 100,000 lbs. (Photo 2). It was an articulated vehicle with a front plow to push and spread the waste and sand, and with two sets of double metal wheels to crush and compact the waste. Each metal wheel was six feet in diameter and had 28 evenly staggered triangular metal cleats that were eight inches in height (Photo 3). The compactor moved at a speed of five to six miles per hour. The vehicle had an audible backup alarm, a rearview mirror in the cab and four side mirrors, two on each side.

Photo 2. A landfill compactor.

Because of the length and height of the vehicle, the operator's blind spot extended from the rear of the vehicle up to 35 feet behind; the operator could not see a person unless he or she stood further than 35 feet away from the rear of the compactor.

Recommendation #3: Landfill employers should consider using additional safety devices for landfill equipment, to warn drivers when someone is in their blind spot.

- Readily available devices include video cameras that can be mounted on the vehicle to monitor blind spots on the front, rear and side of the vehicle. A video monitor in the cab provides the equipment views.
- Other types of devices may also be available including electromagnetic signal detection, infrared detection, and ultrasonic systems.

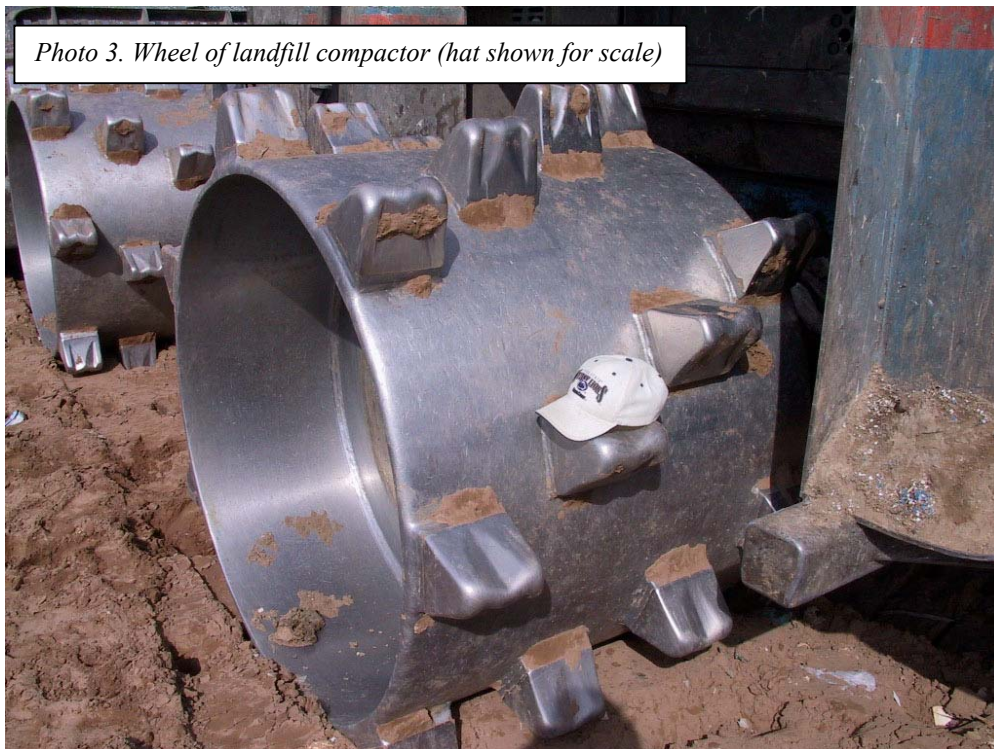
Photo 3. Wheel of landfill compactor (hat shown for scale)

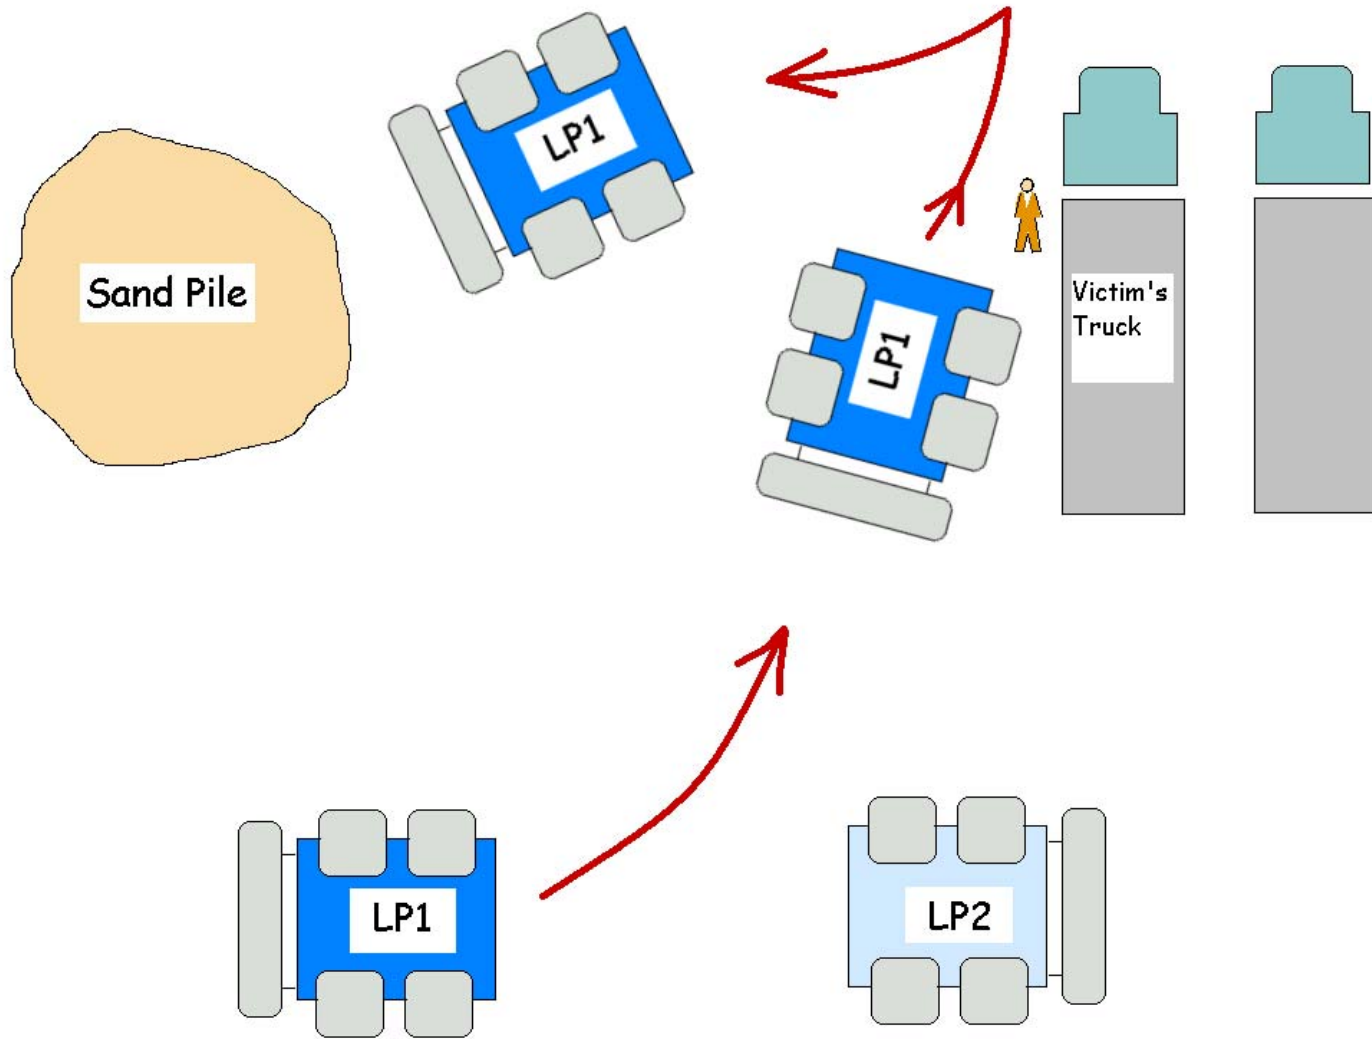
Just prior to the incident, LP1 moved to the left (southwest) side of the victim's truck and LP2 remained at the rear (south) of the two trucks (see Figure 1). At approximately 2:20 p.m. the trailer was completely unloaded and swept. The LP2 operator stated that he saw the driver jump off the rear of the trailer and walk along the west side of the trailer toward the cab carrying his broom. At the same time, LP1 was backing up next to the victim's truck to get sand from a sand pile located at the left (west) side of the trucks. According to the landfill company representative, the back up alarm of LP1 was working properly at the time of the incident. The LP1 operator stated that he looked through both the back and side mirrors before backing up, and did not see the victim in his path. When LP1 curved to the left (west), away from the side of the victim's truck, to approach the

sand pile, the LP2 operator, whose view of the victim was temporarily blocked by LP1, saw the victim lying on the ground next to his semi-truck, waving his hands. The LP2 operator radioed the LP1 operator to check on the victim. The LP1 operator stopped the compactor immediately and ran over to the victim, who was lying on his back approximately five feet from the driver's side of the truck next to the platform behind the cab, with his broom lying next to him. The victim had massive crushing wounds on his left torso (pelvic area) and left leg. It appeared that at the time of the incident, the victim was walking to the front of the truck to put the broom back when he was struck by the LP1 compactor as it was backing up. The LP1 operator immediately radioed the landfill superintendent for daily operations and summoned the local emergency rescue crew, who arrived within minutes. The victim was transported by helicopter to a hospital trauma center 50 miles away, where he died six days later as a result of the injuries.

Figure 1 - Illustration of Accident

Recommendation #1: Landfill employers should develop a landfill traffic control plan that can be used to coordinate the movements of personnel on foot, landfill mobile equipment and delivery trucks on a working face or on any other landfill operations that involve multiple mobile equipment.

Recommendation #2: Landfill employers should develop and enforce a policy that requires delivery drivers to remain in the truck cab during unloading.
