STATE OF NEW YORK DEPARTMENT OF HEALTH

FATALITY ASSESSMENT AND CONTROL EVALUATION

Truck Driver Killed when Struck by Laminated Veneer Beams Falling from a Forklift Case Report: 02NY027

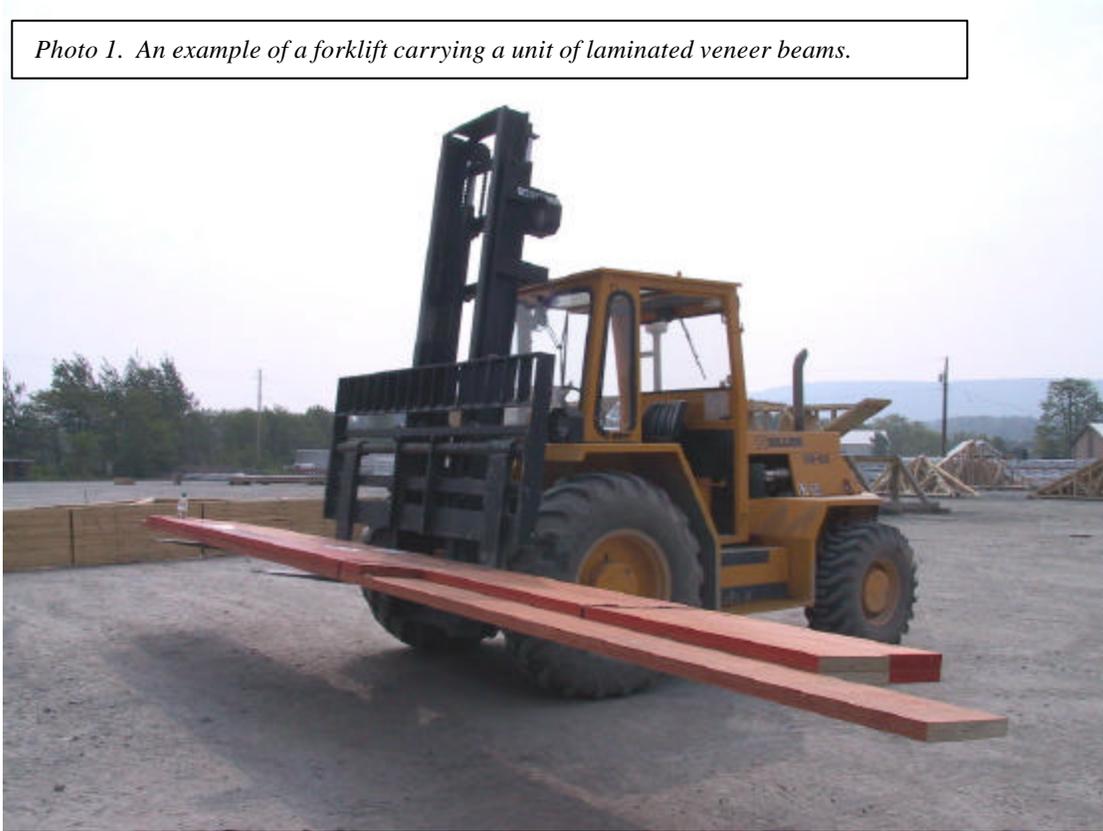
Photo 1. An example of a forklift carrying a unit of laminated veneer beams.

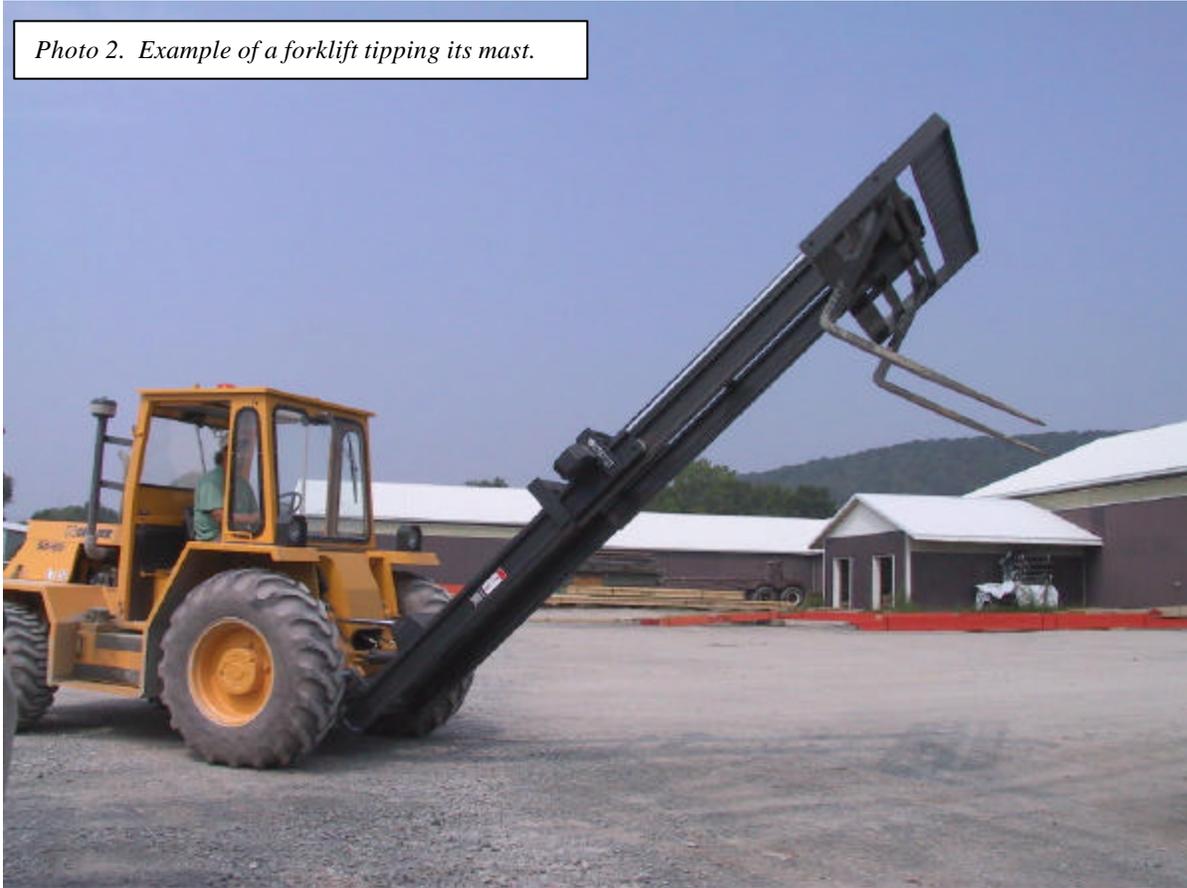
Because the load had to be placed in the middle of the trailer and there were no spacers for the forklift to set the forks in, the forklift operator had to tip the mast to slide the unit into position. While the unit was being lifted and tipped, the end that was close to the rear of the trailer started to slide off the forks first. The victim tried to get away from the sliding beams by running toward the front end of the trailer. The unit quickly hit the previously loaded beams on the trailer. The impact

Photo 2. Example of a forklift tipping its mast.

Recommendation #1: *Employers should develop and implement standard safe loading procedures for forklifts and ensure that all workers follow the procedures.*

- Only stable or safely arranged loads should be handled;
- Always use spacers in between orders or units to avoid forklift tipping and sliding loads;
- No spotter/helper should ever stand under, in front of, or near a moving load;
- Always keep the spotter/helper in the forklift operator's sight.

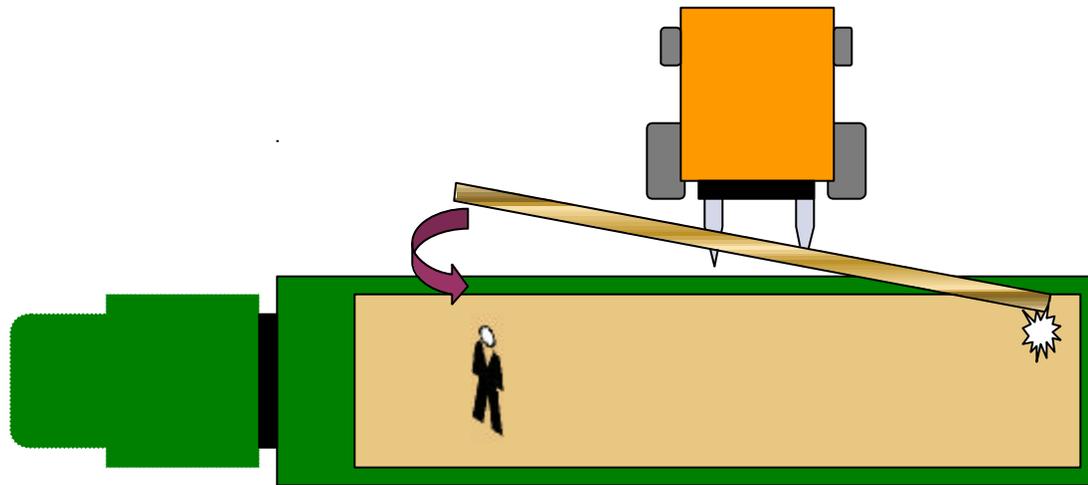
Figure 1. Top View of Incident Scene

caused the unit to bounce and swing rapidly toward the victim (Figure 1). The unit then slid off the forks and struck the victim. The victim fell off the trailer, and his head was crushed by the load. The forklift operator immediately stopped the forklift and ran to the victim who was on the ground next to the driver's side of the trailer. The victim, who was not wearing a hard hat, was found unresponsive with a massive head injury. The forklift operator immediately called for an ambulance. EMS and the local police department responded within minutes and secured the accident site. The victim died instantly. The medical examiner was called, arrived at the site, and pronounced the victim dead at the scene. The victim was transported from the accident site to a local funeral home.
