# STATE OF NEW YORK DEPARTMENT OF HEALTH

## FATALITY ASSESSMENT AND CONTROL EVALUATION

### Millwright Killed When Aerial Work Platform Tipped Over Case Report: 03NY034

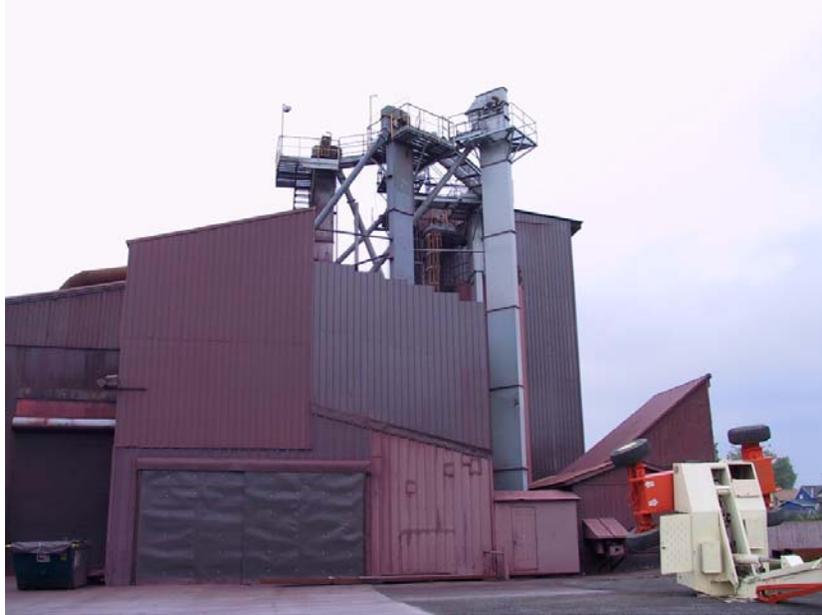
Figure 1. Bucket elevator that was being inspected by the victim during the fatal incident.

At approximately 3:30PM, the maintenance crew finished removing the fiberglass stacks. The supervisor and the victim discussed doing a visual inspection of the exterior of a bucket elevator (see Figure 1). The supervisor left after the discussion and the victim proceeded to perform the inspection. The bucket elevator was approximately 70 feet high and was used to transport iron oxide powder into the plant. The maintenance department inspected the elevator and looked for wear and rust spots approximately once every six months. The unpaved ground around the elevator was solid with grades less than 4 degrees ( $^{\circ}$ ). The manufacturer required that the platform should be leveled within 5 $^{\circ}$ . The tires of the platform appeared properly inflated and had good treads based on the post incident examination.

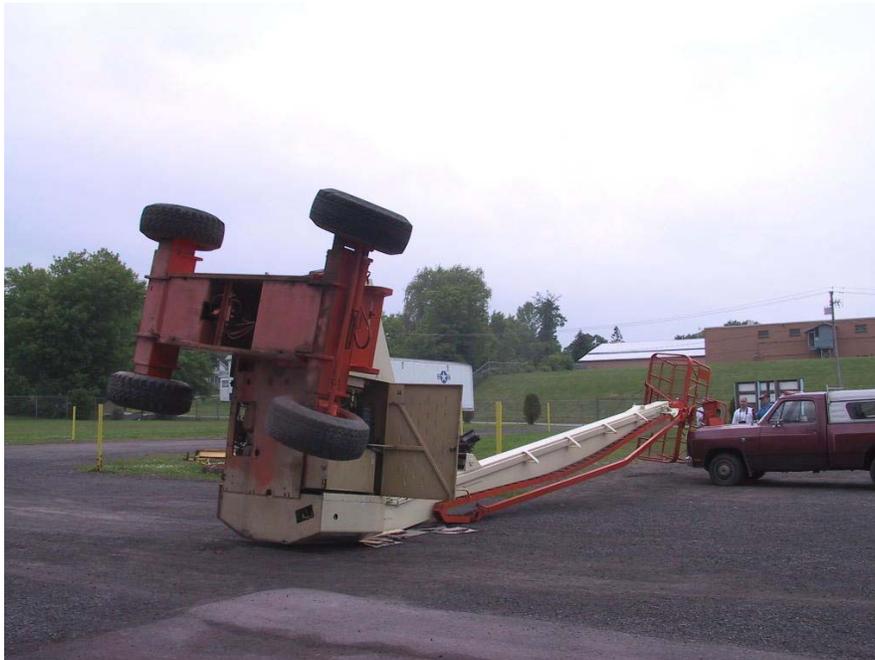
The aerial lift was manufactured in 1990. Its work platform capacity was 500 Lbs. and the hydraulic-operated extensible articulating boom could be extended to a maximum height of 80 feet. In order to increase the vehicle's stability, the lift was equipped with an extendable axle - a stabilizing device that can expand the front steering wheel base from 80 inches to 120 inches. The manufacturer's Operators and Safety Manual required that all operators properly position the extendable axle and lock it into position before raising the platform or extending the boom. The lift had two safety features that were designed to ensure the use of the stabilizing device: an axle set indicator (warning) light and an interlock. When the axle was not extended and locked, the warning light would illuminate; while the interlock would prohibit the boom to be extended more than 10 feet and raised above horizontal. According to the test performed after the incident, the axle warning light worked, but the interlock did not. A forensic examination of the inoperable interlock was performed and the result was not released by the representatives of the involved parties due to litigation at the time that this report was written.

Figure 2. The aerial work platform tipped over during the incident and hit a pickup truck that was parked near by.

Just prior to the 3:45PM incident, the co-worker saw the victim in the platform directly underneath the elevator's catwalk, approximately 54 feet high. A few minutes later the co-worker and a swing shift millwright who had just arrived at the plant heard and saw the lift falling (see Figure 2). According to the post-incident investigation, the boom was extended to 38 feet when the lift tipped. The platform hit a pickup truck parked nearby, resulting in the victim, who was still attached to the platform by the intact lanyard, being bounced out of the platform. The two millwrights ran to the

**Recommendation #2:** *Employers should require that the operators inspect the aerial lift and test critical safety features before each use and perform safety checkups each time the platform is repositioned during operation.*

**Discussion:** Employers should require that the operators examine and inspect an aerial lift before each use. The pre-start inspection should include more than simply checking the fuel and oil

supplies. A check of all components should be made to assure their security and proper functioning. A functional check of all systems, under no load, should be performed daily once the machine is ready for service from the ground control panel if possible. All critical safety features, such as interlocks, warning lights and alarms should be thoroughly tested. If the examination shows any condition adversely affecting the safety of the equipment, employers should not allow it to be placed in service.

Each time when the aerial lift is repositioned during operation, the operators should ensure that the platform is operated on a surface within the limits specified by the manufacturer, and the outriggers, stabilizers, extendible axles, or other stability enhancing means, are used as required by the manufacturer. Employers should ensure that the operators follow the requirement through close supervision and work site inspection performed by a qualified person.

**Recommendation #4:** *Leasing companies should always inspect safety features on an aerial platform to ensure that it is in working order before the equipment is released for delivery to a customer.*

**Discussion:** Aerial platforms should be inspected, serviced and adjusted to manufacturer's requirements prior to each lease. The critical safety features should be tested. All malfunctions or problems identified should be corrected before the equipment is placed in service.
