# STATE OF NEW YORK DEPARTMENT OF HEALTH

## FATALITY ASSESSMENT AND CONTROL EVALUATION

### City Employee Killed when Clothing became Entangled around an Unguarded PTO Shaft on a Salt Truck Case Report: 05NY007

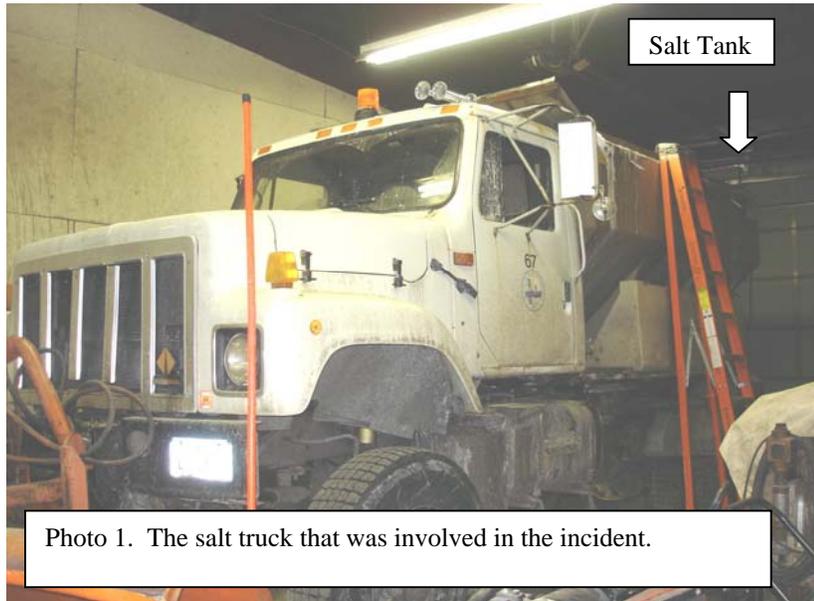
The DPW had two salt trucks, both purchased new in 1993. Each truck had a snow plow in front, a seven cubic-yard salt tank in the back (Photo 1), and a salt spreader at the rear end of the truck. There was a conveyer bed chain on the bottom of the salt tank to transport the salt to the spreader (Photo 2). The conveyer chain was driven by a hydraulic motor through a PTO shaft or a worm gear assembly (Photo 3). The PTO shaft operated between 800 and 1200 RPM with a torque of 1150 inch-pounds. The shaft stub was one inch in diameter and two inches long. Under normal circumstances, the stub was enclosed and guarded by a metal cap (the shaft guard) that was secured to the gear casing with two screws (Photo 4). The PTO assembly was located on the driver's side of the truck towards the back end, approximately five feet and three inches above ground level.

Photo 1. The salt truck that was involved in the incident.

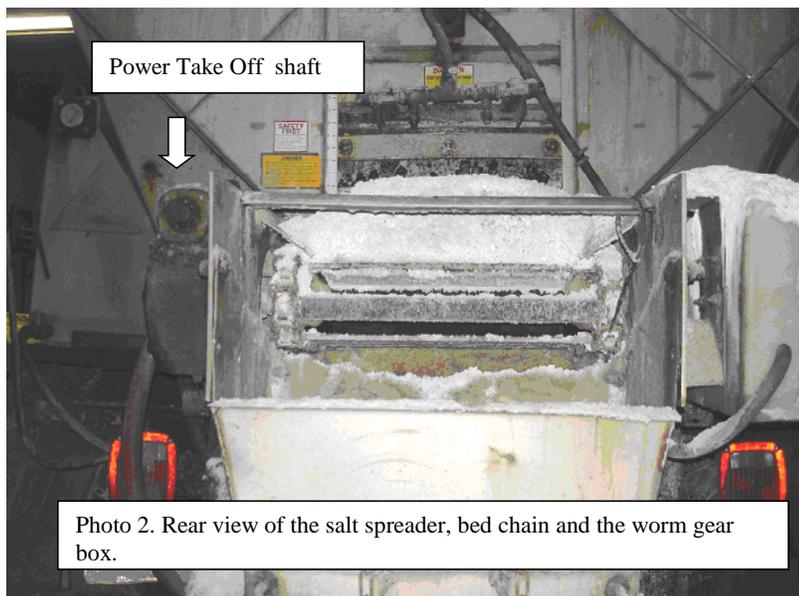
Photo 2. Rear view of the salt spreader, bed chain and the worm gear box.

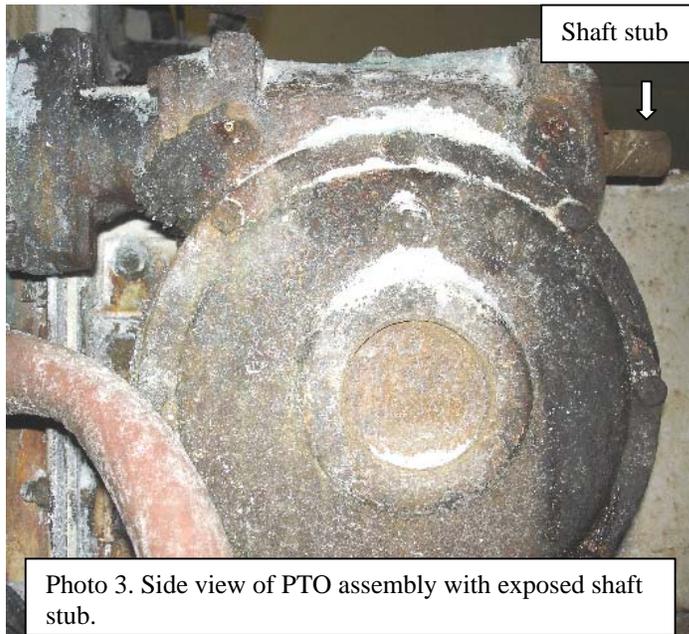
Photo 3. Side view of PTO assembly with exposed shaft stub.

**Recommendation #1:** *Employers should require maintenance staff to inspect and certify each piece of equipment before releasing it back into service after maintenance or repair.*

**Discussion:** Each piece of equipment that has undergone maintenance or major repair should be inspected and certified by DPW maintenance staff before it is released back into service. The DPW maintenance staff should verify and certify that the equipment is safe to operate and that all safety features, including machine guards, are in satisfactory condition and have been replaced after repairs. A fill-in inspection checklist may be developed to assist with the inspection. The inspection should be documented and records retained.

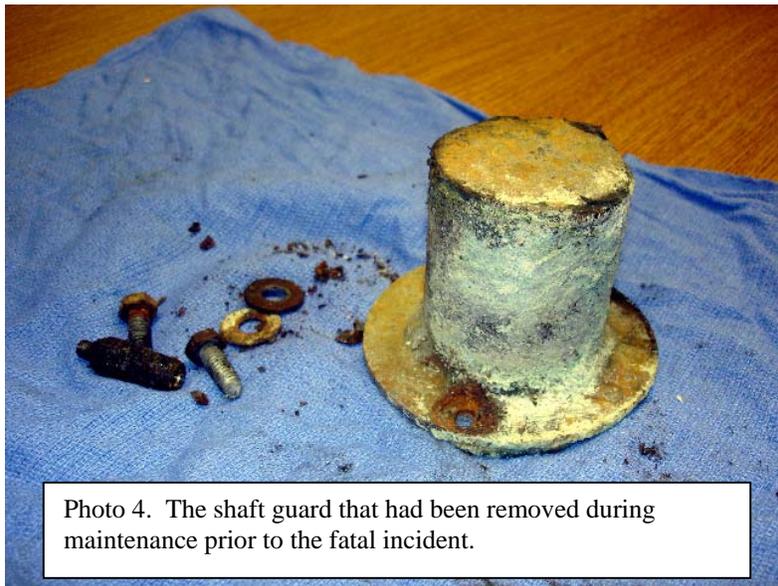
All of the removed truck parts were transferred to the other garage except for the shaft guard and the attachment screws and washers. These parts were left on a bench and covered with a piece of

paper towel in the garage pit. The truck was put back into service that Friday without the shaft guard. Between that Friday and the next Wednesday, the day of the incident, the truck had been operated by numerous workers in addition to the victim.

Photo 4. The shaft guard that had been removed during maintenance prior to the fatal incident.

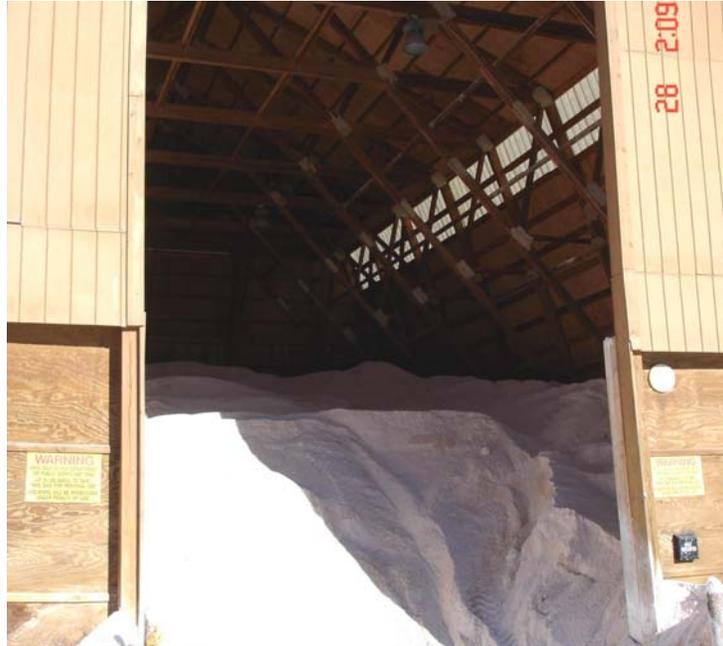
Photo 5. The entrance to the salt shed where the victim parked his truck at the time of the incident.

A potential contributing factor to the incident was the access space inside the shed (Photo 5). At the time of the incident, the victim walked on the piled salt around the rear end of the truck. This unstable footing may have contributed to his contact with the shaft.
