## **FATALITY ASSESSMENT AND CONTROL EVALUATION**

### **Tower Technician Killed When Guyed Tower Collapsed Case Report 09NY095**

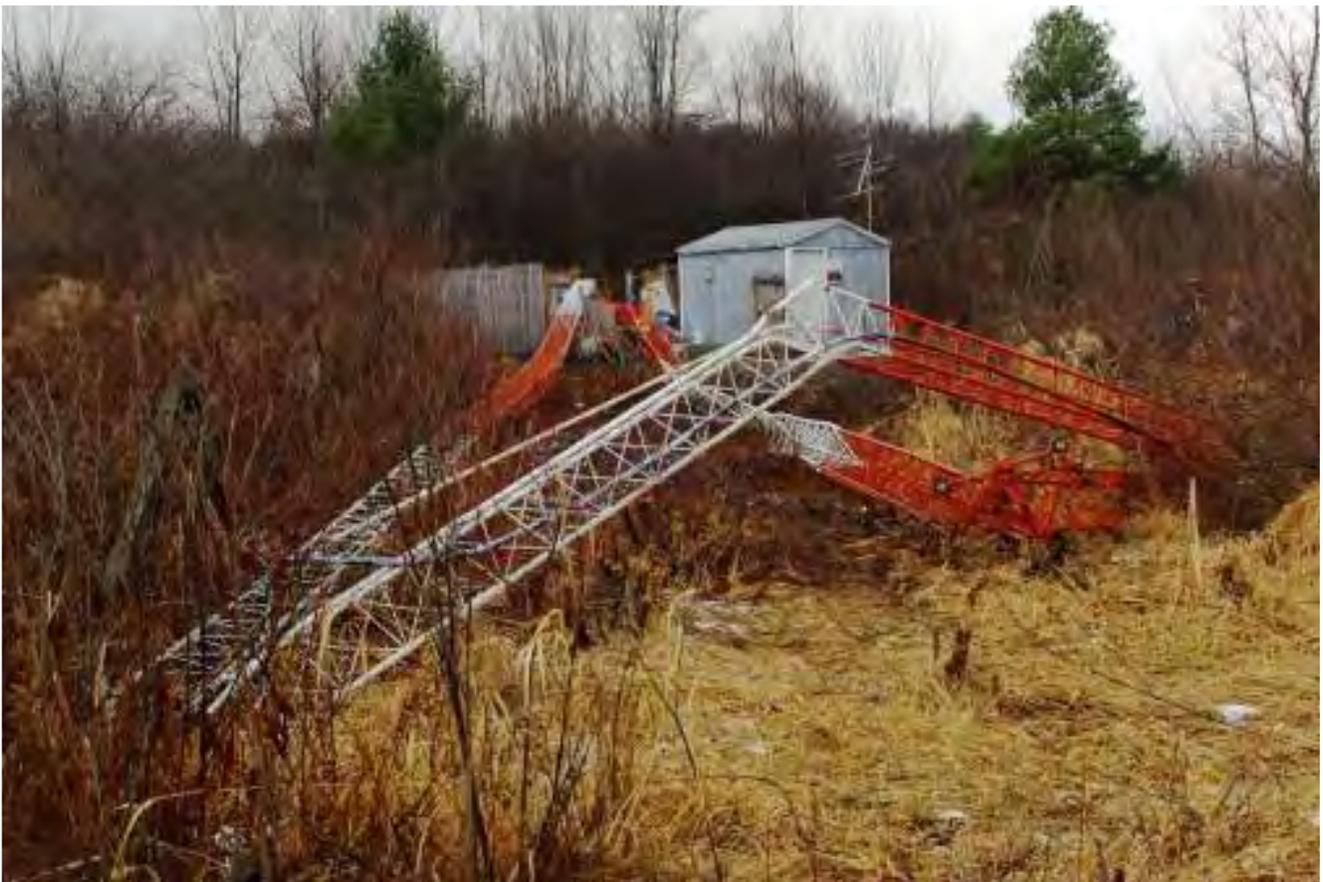
*Photo 1. The 380 foot tall guyed tower collapsed killing a 46 year-old tower technician (photo courtesy of OSHA).*

The OSHA compliance officer who investigated the case examined the collapsed tower. He did not observe any signs of material failure that could have caused the collapse. According to the OSHA compliance officer, the tower collapsed in such a manner that it indicated a “layered collapse.” The free standing lower section fell first followed by the upper sections that were being pulled by the remaining guy wires. It was concluded that following factors may have contributed to the collapse of the tower:

- Removal of the guy wires at 43 feet resulted in an unsupported lower section of 93 feet;
- The new guy wire was pulled hand tight without touching the ground. The weight of the wire added a sideways force to the tower.
- The guy wires were over-tensioned.
- The weight and movement of the climber might have further destabilized the tower.
- The tower was not constructed according to the manufacturer’s specifications.

**Recommendation #1:** *Communication tower owners should have a structural analysis completed and the tower structural integrity confirmed before sending contractors to work on a tower.*

**Recommendation #2:** *Communication tower contractors should use temporary guy wires to maintain tower structural integrity when replacing guy wires on a guyed tower.*

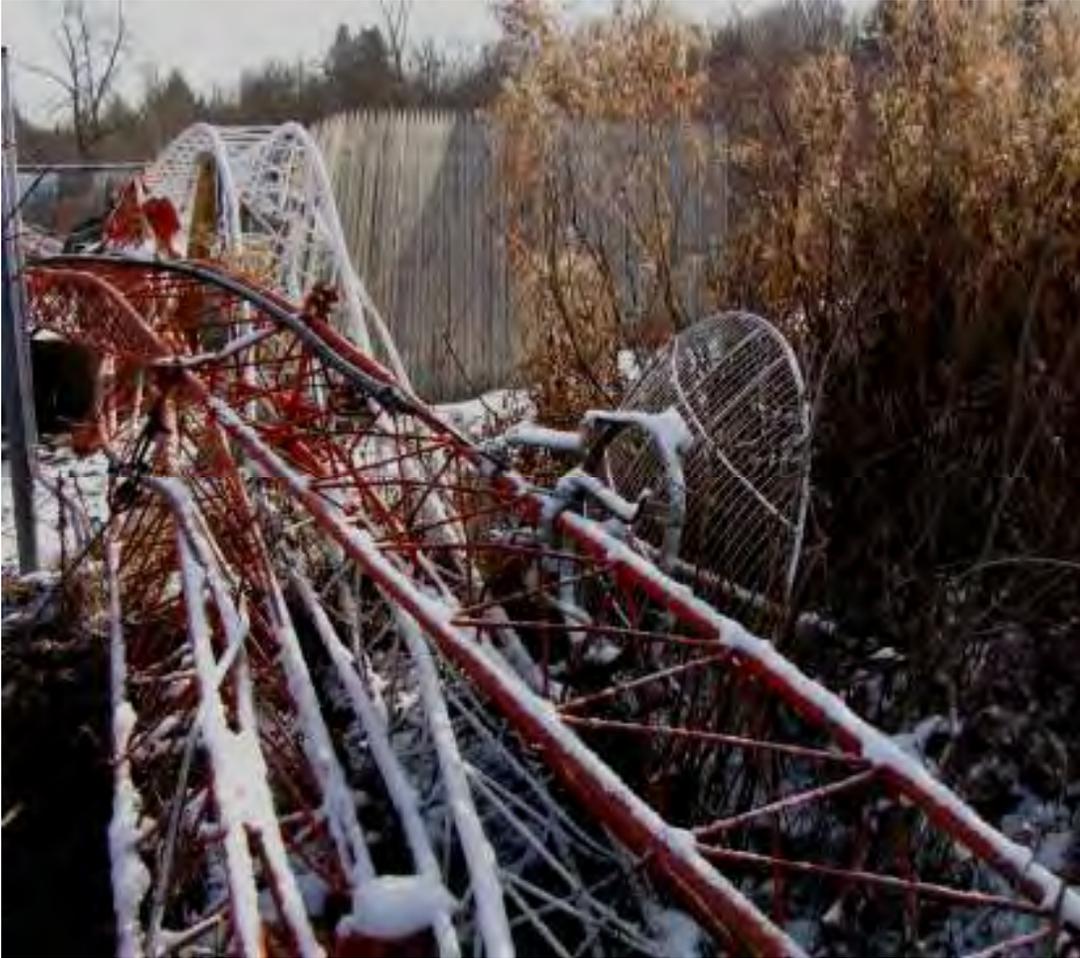
*Photo 2. The collapsed communication tower (photo courtesy of OSHA).*

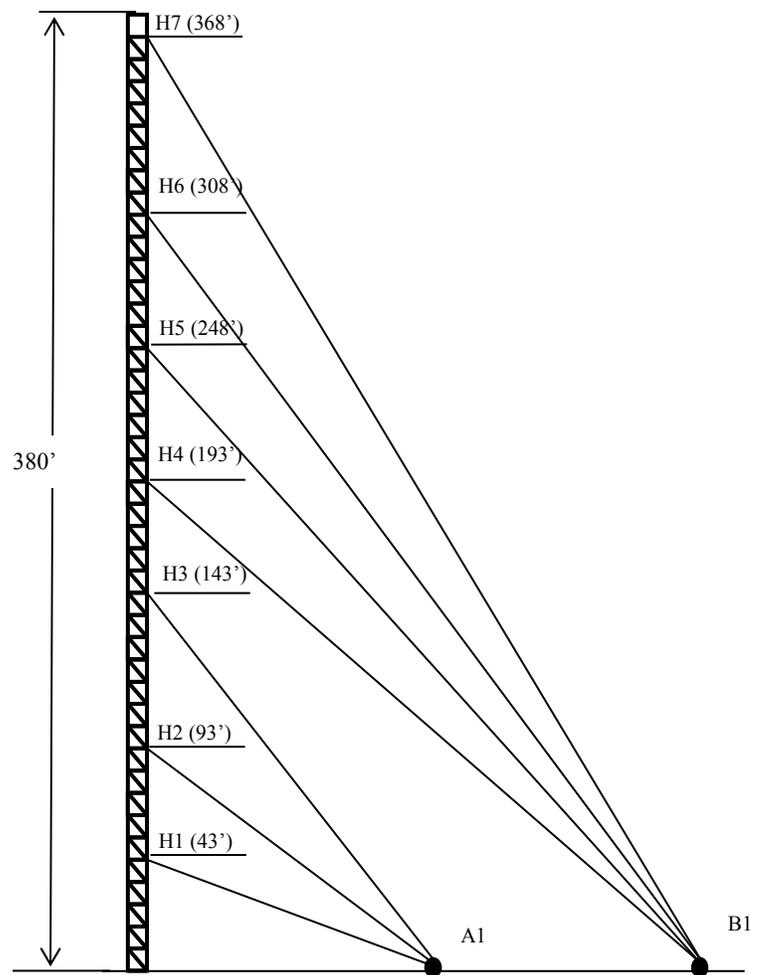
The base of the tower was mounted on a metal pin that was embedded into a concrete base in the ground (Photos 3 and 4). The tower was guyed at three corners of the triangle at seven elevations ranging from H1 to H7 respectively at 43, 93, 143, 193, 248, 308 and 368 feet (Figure 3). All guy wires were 1/4 inch diameter cable, with the exception of the three at H7 (368 ft). The H7 guy wires were 5/16 inch diameter.

Figure 3\*. The guyed tower, the guy wires and the ground guy anchors. Each set of three guy wires were attached to the tower at seven elevations (H1-H7).

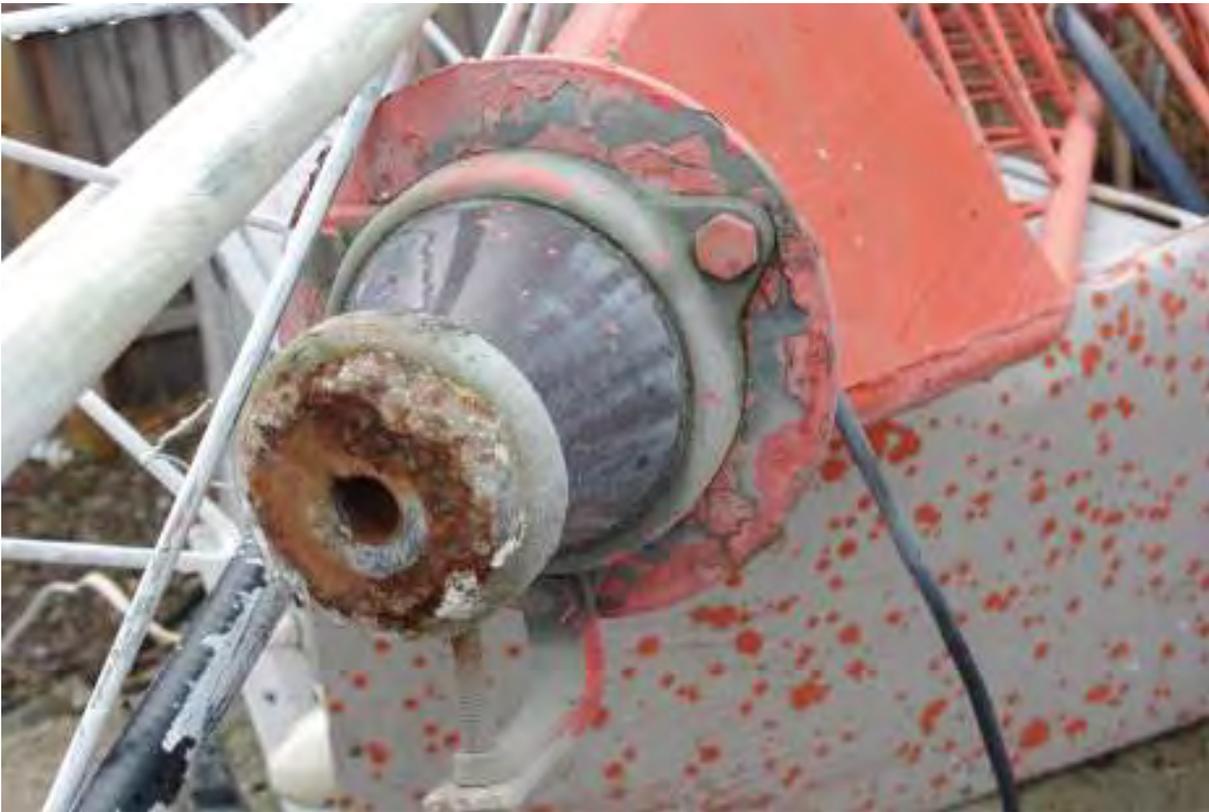
*Photo 3. The base of the communication tower (photo courtesy of OSHA).*

**Discussion:** Most guyed towers, including the one in this case, are mounted on top of a concrete mound that has a metal pin embedded in it. The pin fits into the tower’s base plate (Photos 3 and 4). The base keeps the tower from sinking under the deadweight of the tower and the pressure of the guy wires. However, the tower base does not keep the tower upright. A guyed tower relies solely on the guy wires to resist lateral forces such as wind loads to stay upright. The guy wires must be properly installed, tensioned, and secured to ground anchors according to the manufacturer’s specifications. If any guy wires are missing or not tensioned properly, the structural integrity of a guyed tower is compromised and the tower may buckle or collapse.

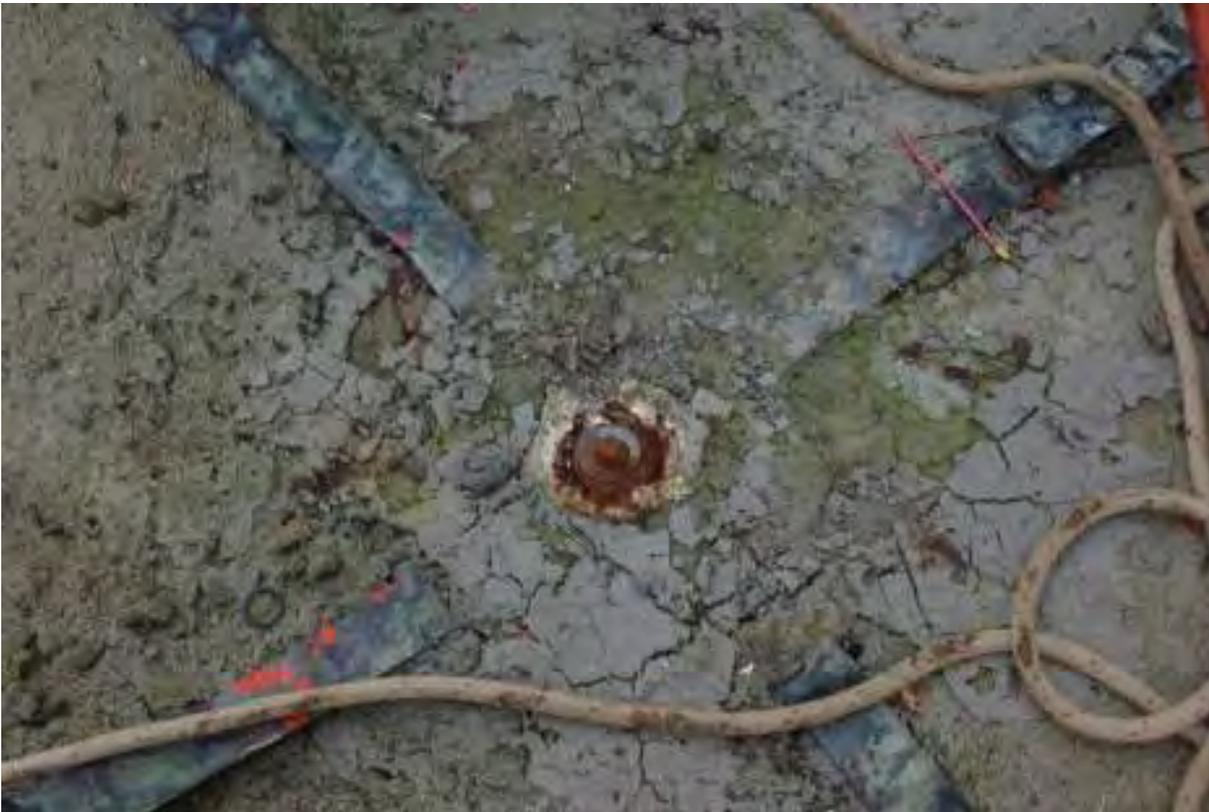
*Photo 4. The cement base with a metal pin embedded. The base of the tower was mounted on the pin (photo courtesy of OSHA).*

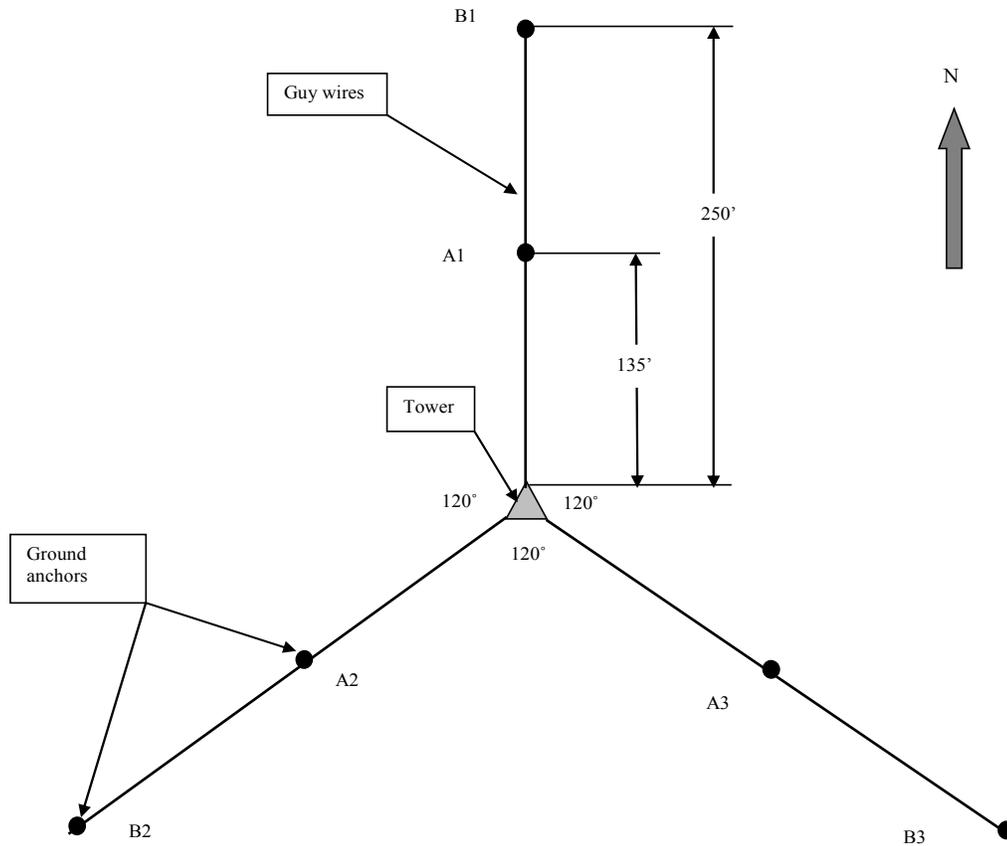
Two sets of three ground anchors that were 120 degrees from each other were used to secure the guy wires to the ground (Figure 4). The first set of the anchors (A1, A2 and A3) that were closer to the tower (the interior anchors) were 135 feet from the base of the tower. The exterior anchors B1, B2 and B3 were 250 feet from the base of the tower. The guy wires at the three lowest elevations (H1, H2 and H3) were secured to the three interior anchors, while the guy wires at the higher elevations (H4 – H7) were secured to the exterior anchors.

Figure 4. Top view of the tower, the guy wires and the six ground anchors (drawing is not to scale).
