FATALITY ASSESSMENT AND CONTROL EVALUATION

Ironworker Foreman Crushed when Bridge Support Element
Broke During Dismantling
Case Report: 05NY013

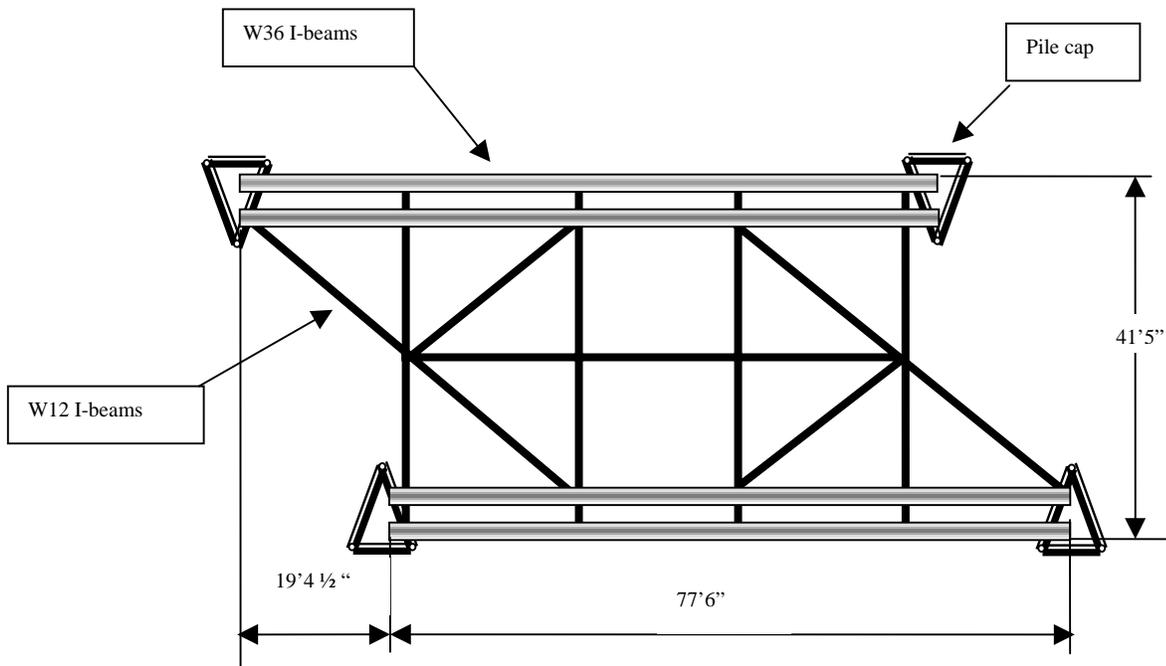
Figure 2. Overhead depiction of the third span of the temporary under-bridge.

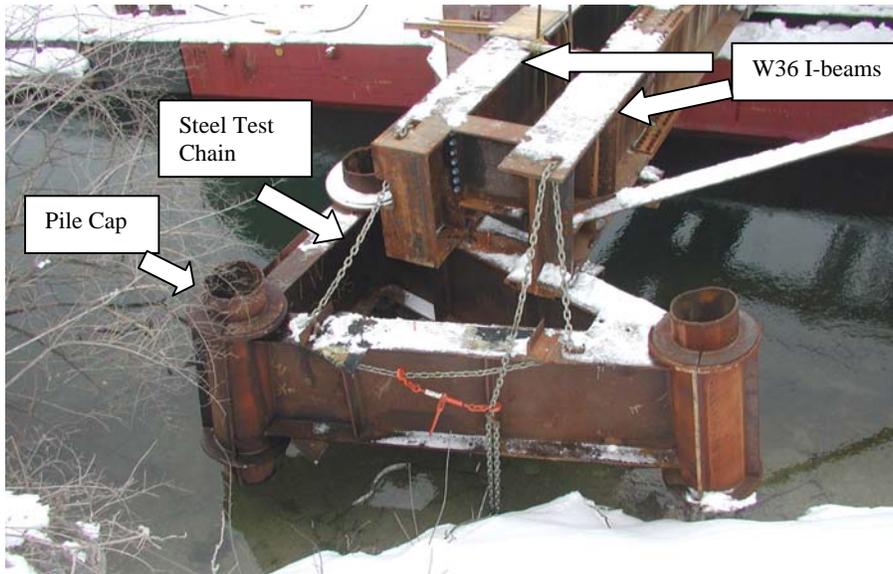
Photo 1. A pile cap that was attached to a pair of W36 I-beams and secured with a 12,000 lb. steel test chain.

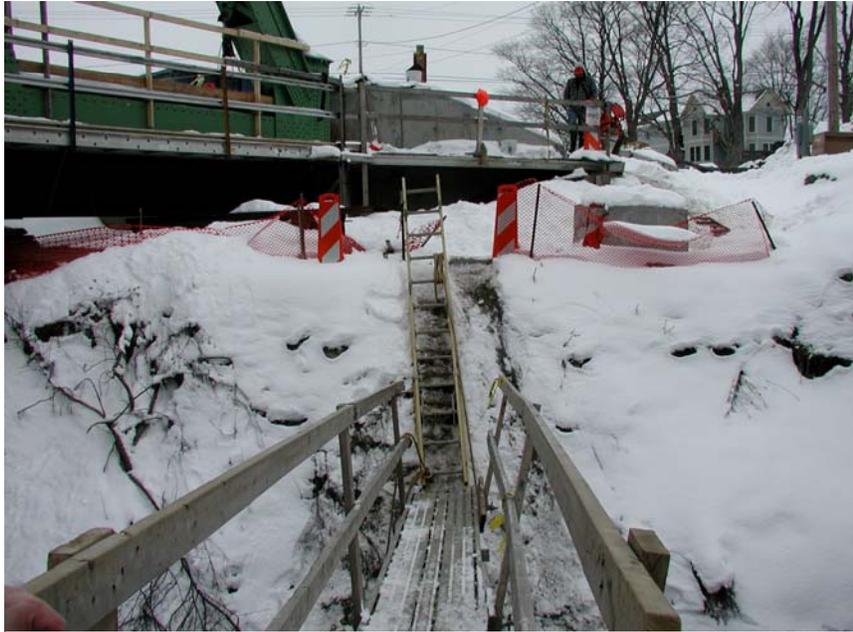
Photo 3. The ladder and catwalk that served as the only entrance to the barge.
