FATALITY ASSESSMENT AND CONTROL EVALUATION

Equipment Operator Fatally Crushed by the Bucket of a Front-End Loader at a Scrap Yard
Case #: 18NY019

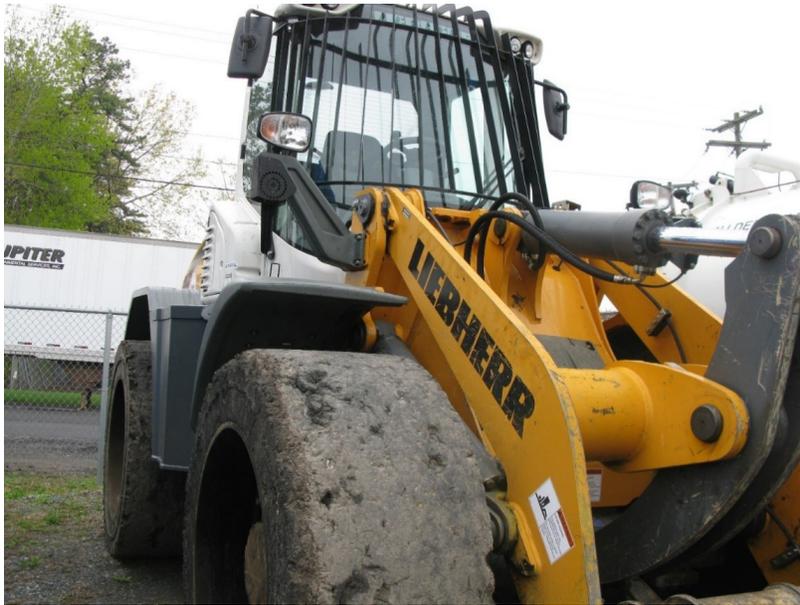
Photo 3. The front wheel fenders that were missing at time of the incident were reinstalled after the incident.

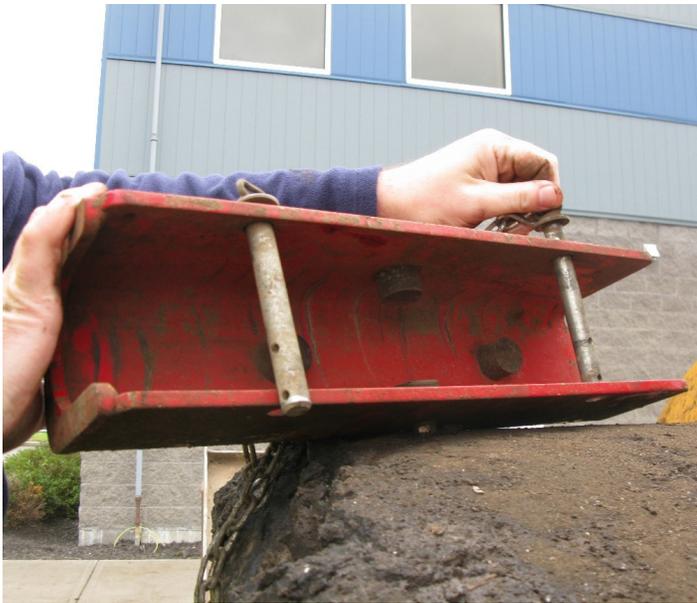
Photo 4. The lift lock, a metal piece (13" X 4" X 4") with two cotter pins, was used to secure the bucket.

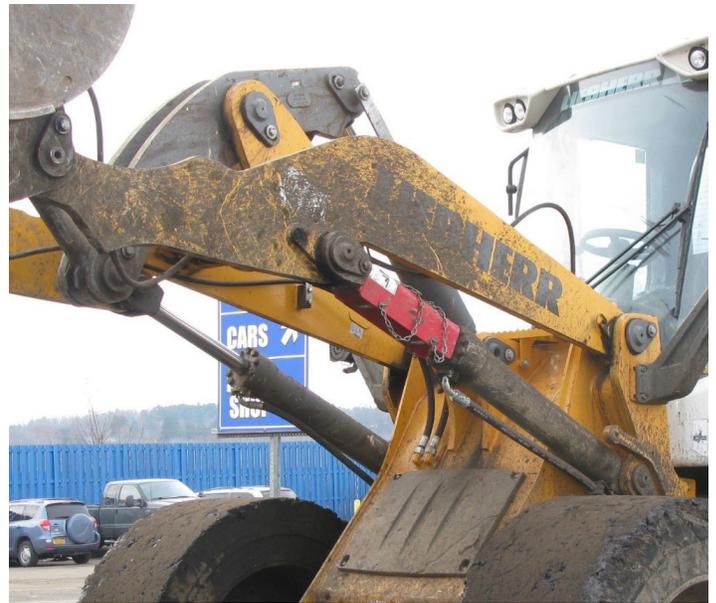
Photo 5. The lift lock is placed on the piston rod of the lift cylinder to secure the bucket and prevent it from dropping.

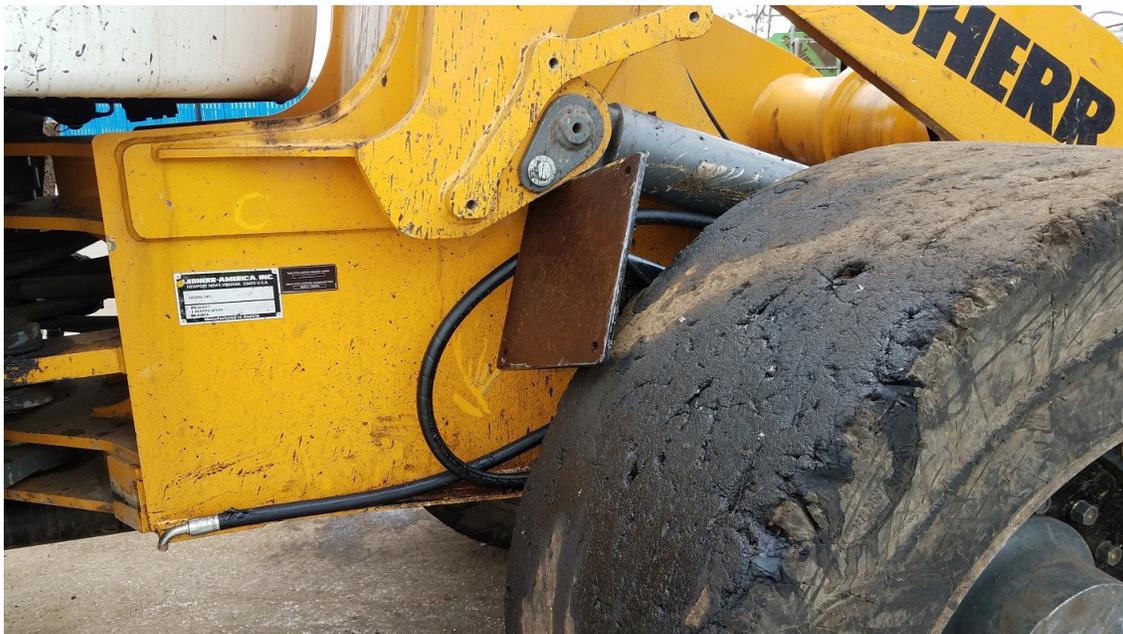
Photo 6. A scrap piece with a square plate became wedged between the lift cylinder and the wheel, and it pulled the hydraulic hose off its fitting.
