FATALITY ASSESSMENT AND CONTROL EVALUATION

A 23-Year-Old Worker Pulled into a Wood Chipper on His First Day on the Job
Case #: 16NY024

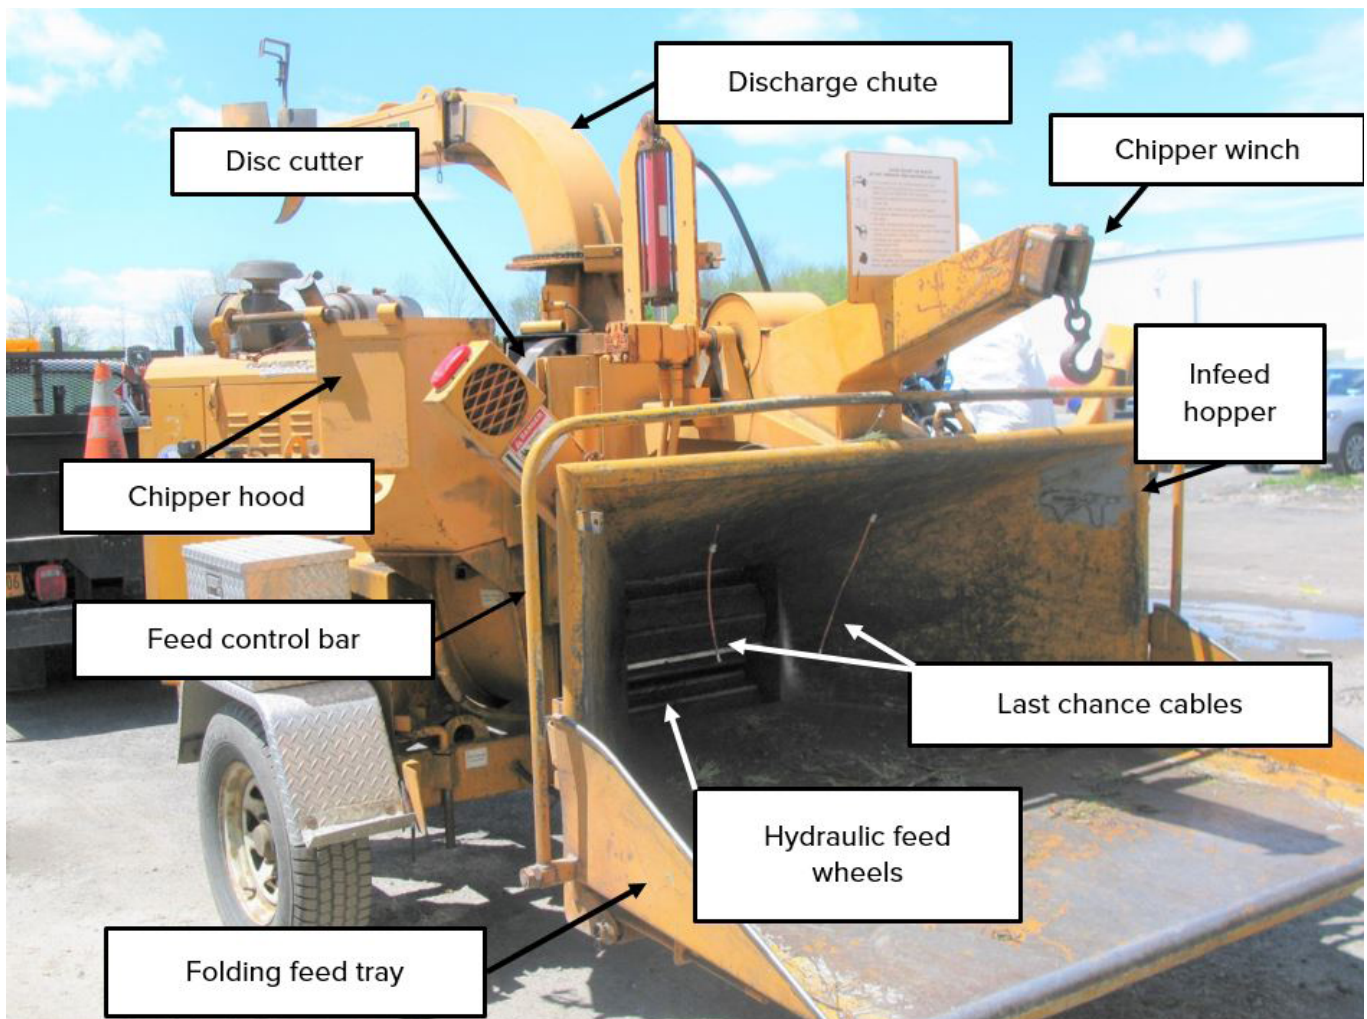
The wood chipper was a handfed disc style wood chipper (Model: Bandit 250, Photo 1) with cutting capacity up to 12 inches in diameter. The chipper consisted of a 110-HP diesel engine, a folding feed tray, a feed hopper, an automatic feed mechanism, a chipping disc, and a discharge chute. The main component of the automatic feed mechanism was a pair of hydraulic horizontal feed wheels located between the infeed hopper and the disc cutter. Tree materials were placed on the feed tray and fed into the hopper until they were caught by the rotating feed wheels. The feed wheels pulled the materials into the disc cutter at a speed of 2 feet per second. With a rotational speed between 1,000 and 2,000 rpm, the disc cutter cut and shredded the woody materials and propelled them through the discharge chute.

The Bandit 250 was equipped with two safety features to control the feed wheels: a feed control bar and two “last chance cables”. The feed control bar was mounted across the top and along the sides of the infeed chute (Photo 1). It had three positions: feed, neutral (off), and reverse feed. A worker could use the control bar to stop or reverse the rotation of the feed wheels during an emergency.

Photo 1. Bandit 250 Brush Chipper that was involved in the incident.

The “last chance cables” were located inside the infeed hopper and pulling them could reverse the feed wheels (Photo 1). The folding feed tray was 19 inches above ground, 30 inches deep, and 60 inches wide (Figure 1). The infeed hopper opening was approximately 36 inches long, 60 inches wide, and 36 inches deep. The last chance cables were 18 inches from the feed wheels.

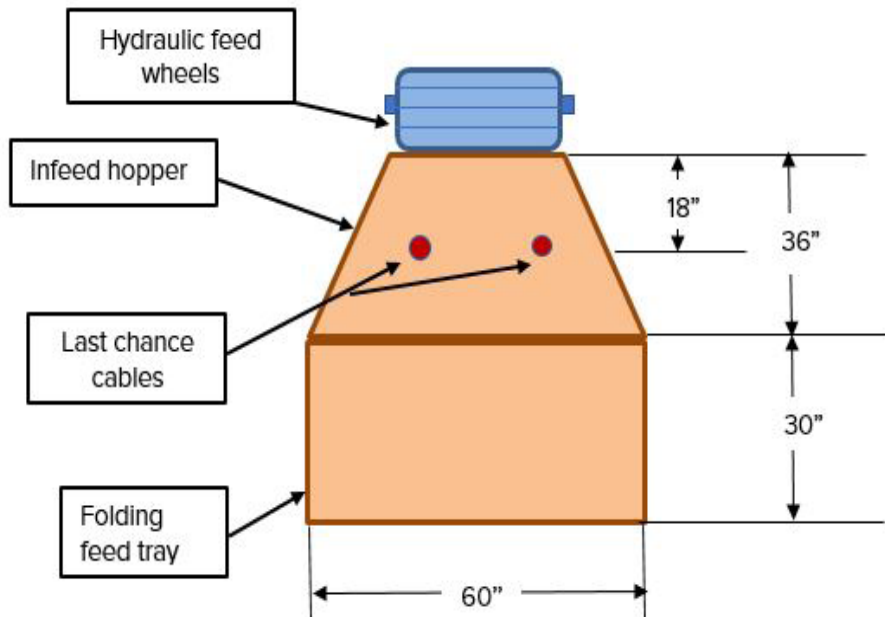
Figure 1. Location of the last chance cables on Bandit 250.

If a worker fed the chipper from the end of the feed tray, the distance between the worker and the feed wheels would be 66 inches. Based on the chipper’s feed speed of 2 feet per second, the time for a worker to be pulled into the feed wheels was approximately 2.75 seconds. When the worker reached the last chance cables, he would have less than a second, 0.75 seconds to be precise, to pull the cables.

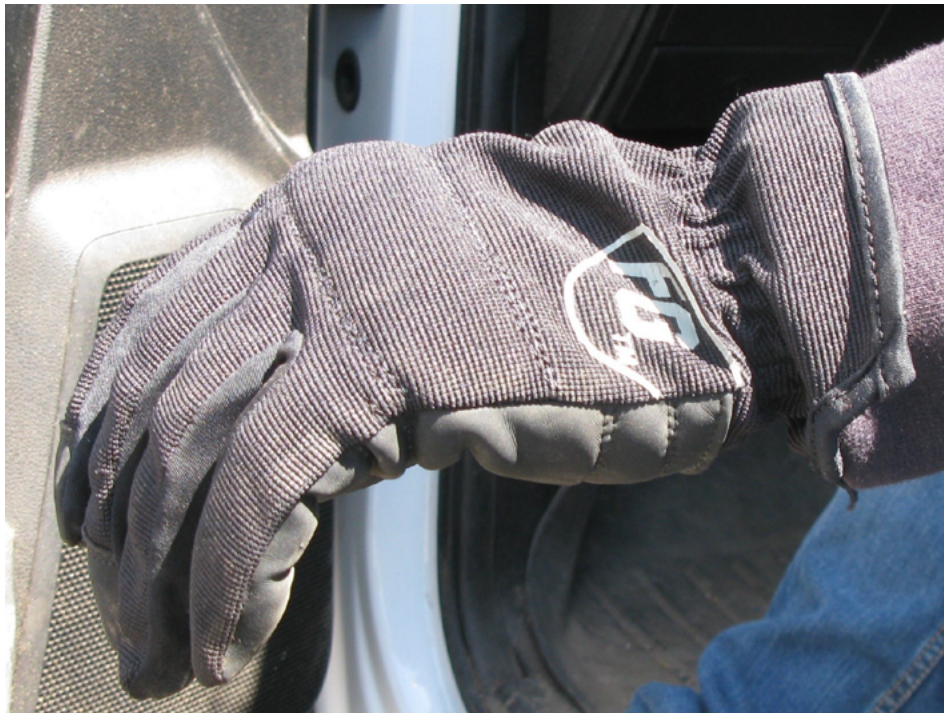
The employer and the four workers along with the crane contractor started working at the first job site around 8 am. The workers were not required to wear any personal protective equipment (PPE), although the employer had hard hats and gloves in his truck that workers could use. The type of gloves that the employer carried were Firm Grip (FG) Utility gloves with loose-fitting short cuffs (Photo 2). The victim was wearing a sweat shirt, jeans,

Photo 2. Gloves provided by the employer with loose-fitting cuffs that may catch branches.

**Discussion:** To prevent entanglement hazards, workers should wear close-fitting clothing, gloves and trousers without cuffs, and skid resistant foot wear. Employers should ensure that workers wear the proper clothing and personal protective equipment including hard hats and eye and hearing protection. The gloves that the employer provided in this case had loose-fitting cuffs that could catch branches, although it was unknown whether the victim's gloves were caught.

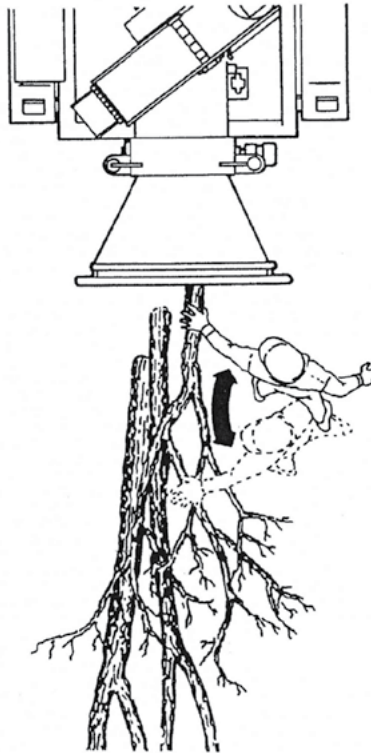
Figure 2. Safe feeding pathway: material fed from side, operator walks away immediately following feeding. (Courtesy of Michigan Occupational Safety and Health Administration, Pub OSC-6125).

- Feed from the curbside to avoid being struck by road vehicles;
- Stay at the side of the machine when feeding to allow quick access to the emergency shut-off device and minimize risk of entanglement in branches (Figure 2);
