#### **WORKERS AT RISK**

# **Dumbwaiters Can Kill**Interlocks on Doors Prevent Tragedy

STATE OCCUPATIONAL FATALITY ALERT NY STATE

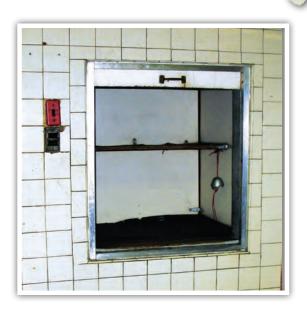
This is the dumbwaiter involved in the Schenectady, NY incident. There were no interlocks on the dumbwaiter. The doors were nailed in the open position. Workers were supposed to use a bell, which is not an appropriate communication control, to alert staff on the other floor before starting the dumbwaiter. In fact, the bell was broken.

- **Install interlocks.** Have an elevator technician inspect the dumbwaiter to make sure that all access doors have a functioning interlock as specified by ASME.
- **Test interlocks.** Conduct routine tests and maintenance to make sure that all interlocks work properly. The dumbwaiter should not move unless the access doors are closed and the doors cannot be opened until the dumbwaiter is in loading position.
- **Use an intercom system** to communicate between floors. Workers should never use the dumbwaiter shaft to talk to each other.
- Train employees so that they are aware of dumbwaiter hazards and know how to operate it safely. Workers should not tamper with the interlocks.
- **Post signs** to warn users of crushing and falling hazards associated with dumbwaiters.
