**FATALITY ASSESSMENT AND CONTROL EVALUATION**

City Engineer Killed in Landfill Manhole  
When Retrieving Flow Meter  
Case Report: 03NY027

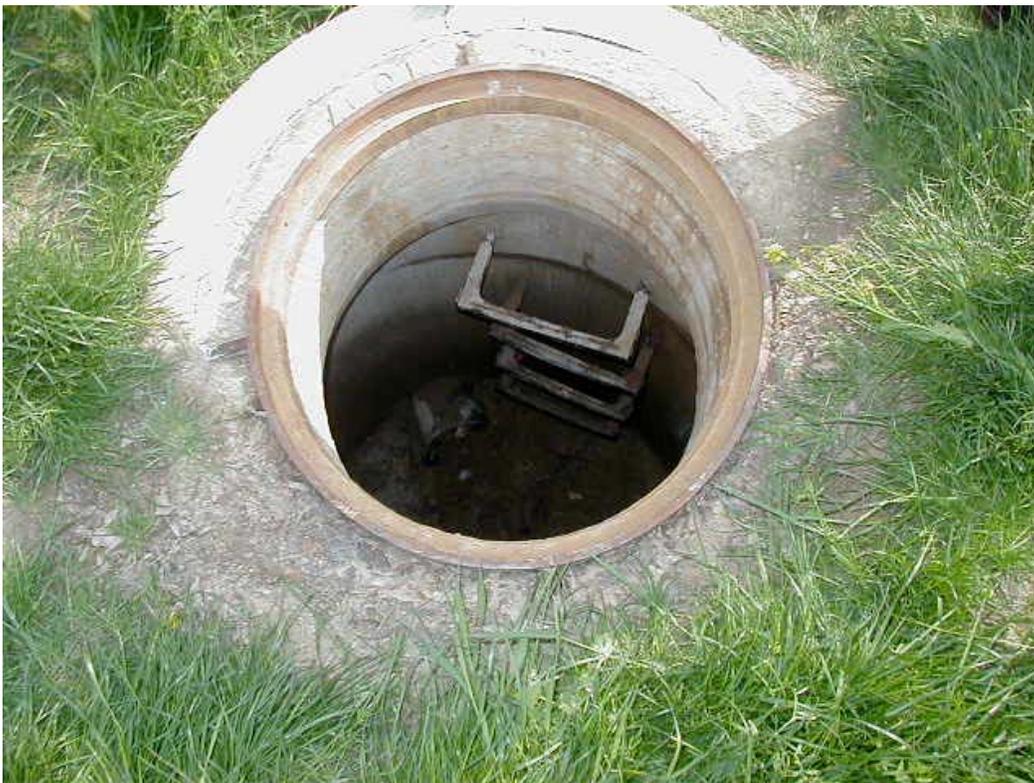
The manhole was 7'4" deep and its inner diameter was 24" (Figure 1). It looked dry at the time of the incident according to the witnesses. There were four iron rungs mounted into the cement wall of the manhole to form a ladder. The flow meter (Figure 2), weighing approximately 15 pounds, was attached to the top rung (34 inches below the manhole opening) by means of a "U" shaped spring loaded handle. A string was looped and tied around the handle of the flow meter.

**Figure 1.** The landfill manhole where the fatality occurred.

According to both witnesses, the entire incident from the time that the victim entered the manhole until he collapsed took only a minute or less. The assistant engineer immediately called “911” on his cell phone while the intern ran to the street to call for help. The fire department arrived at the site within four minutes and immediately started the rescue procedure by following the confined space rescue protocol. The victim was extricated from the manhole in approximately 20 minutes, and transported to a nearby hospital where he was pronounced dead. According to the fire department monitoring data taken at the time of the rescue, the oxygen concentration at the bottom of the manhole was 2.1% and the flammable gas or vapor exceeded 60% of the lower explosive level (LEL).

The cause of death was reported as asphyxia with methane gas.

**Recommendation #1:** *Employers should implement a confined space entry program for all workers who are or could be exposed to confined space hazards.*

**Discussion:** At the time of the incident, the engineering department did not have a confined space entry program, nor were there any effective measures in place to prevent the workers from entering permit-required confined spaces. Employers should conduct a worksite inspection to identify and then appropriately mark all confined spaces. A confined space entry program should then be developed and implemented that would include:

- evaluation to determine whether entry is necessary or whether the task can be performed from the outside;
- issuance of a confined space entry permit by the employer;
- posting of confined space entry warning signs;
- testing the air quality in the confined space when entry is necessary, to ensure:
  - ✓ oxygen levels of at least 19.5%,
  - ✓ flammable range of less than 10% of the lower explosive limit (LEL),
  - ✓ absence of toxic air contaminants;
- training of workers and supervisors in the selection and use of:
  - ✓ respiratory equipment,
  - ✓ environmental test equipment,
  - ✓ lifelines,
  - ✓ rescue equipment,
- training of employees in safe work procedures in and around confined spaces;
- training of employees in confined space rescue procedures;
- use of proper ventilation in confined spaces;
- monitoring of air quality prior to entering confined spaces.

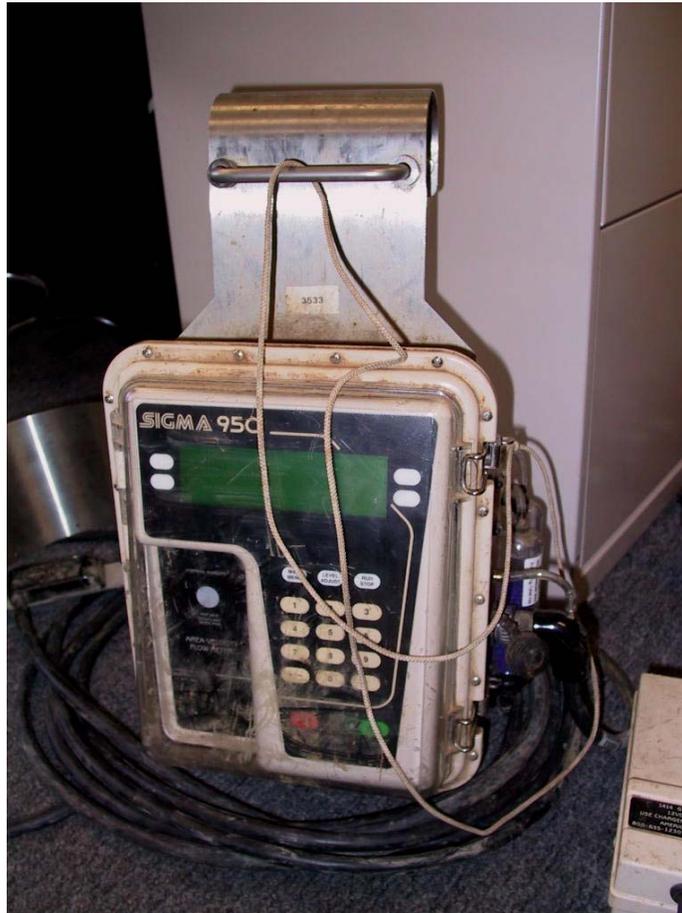
**Figure 2.** The flow meter that was used to measure the flow rate in the manhole.

**Recommendation #3:** *The employer should evaluate the sewer flow monitoring procedure and modify it to reduce employee exposures to the confined space hazards.*

**Discussion:** The employer should evaluate and modify the flow monitoring procedure to reduce the risk by implementing feasible engineering controls. For example, the flow meter may be placed outside a manhole to avoid confined space entry; and downloading data and battery replacement may be performed at the same time, instead of on different days. At the time of the incident, the victim used a regular pickaxe to open the cover of the manhole where the flammable gas and vapor concentration exceeded 60% of LEL. Spark proof tools should be used for manhole cover removal and inside the manhole to reduce the fire and explosion hazard. Proper sturdy tools should be used to retrieve the flow meters. When installing the engineering controls, the confined space entry procedures should be strictly followed.
