FATALITY ASSESSMENT AND CONTROL EVALUATION

Truck Driver Buried by Mulch at Town Solid Waste Site Case Report: 06NY084

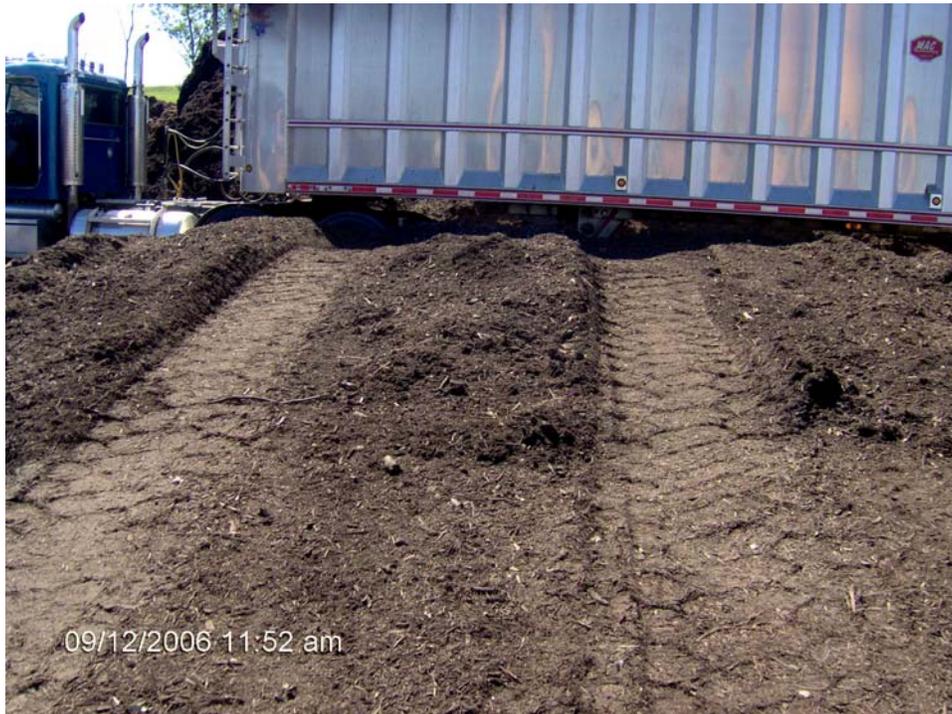
On the morning of the incident, the victim was at the town solid waste site having his tractor trailer loaded with mulch. The victim parked the rig with the front part of the trailer next to a raised loading ramp (Photo 1) as directed by the town staff. A town equipment operator was to load the mulch with a front end loader (Photo 2). The town waste site loading procedure required a driver to stay in the cab when at the loading spot and to remain in the cab for the entire duration of the loading operation. According to the site's procedure, a driver would be expected to move the vehicle forward during loading in order to distribute the mulch evenly within the trailer. The loading operator assumed that the victim knew and understood the procedure since he had picked up mulch at the town site before.

Photo 1. The victim's tractor trailer was parked next to a raised loading ramp during the incident (photo courtesy of OSHA).

Recommendation #1: *Owners of solid waste facilities should develop and enforce a standard safe loading/unloading procedure.*

- 1) Assign a site traffic coordinator to monitor the loading operation and the traffic in loading area;
- 2) Require a loader operator to refrain from discharging a load unless he sees that the driver is inside the cab;

- 3) Require all visiting drivers to remain in the cab during loading. If a driver has to leave the cab in the loading area, the driver must communicate his intention to the traffic coordinator. The driver should remain in the cab unless he receives clear feedback from the traffic coordinator that all parties are informed of his intention and it is safe for the driver to leave the cab. A two-way radio system may be used in addition to conventional communication measures such as visual contact and hand signals; and;

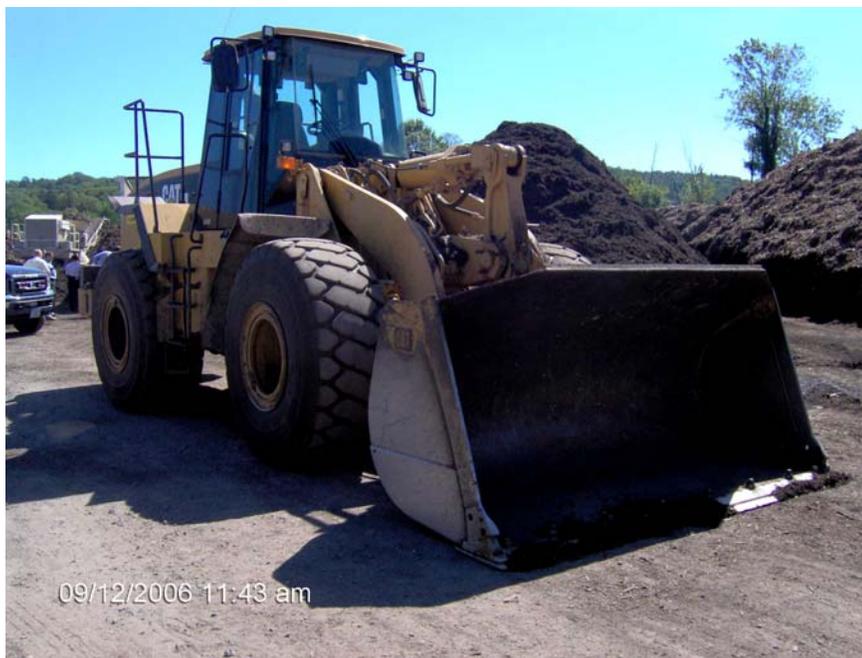
Photo 2. The front-end loader that was involved in the incident (photo courtesy of OSHA).

The loader operator did not notice that the trailer rear door was open when he dumped the mulch into the trailer. According to the operator, the door may have been open just wide enough to allow the victim to enter. From the angle where he was working, the operator could not see the door ajar. The loader operator believed that the trailer door might have swung open by the impact of the first load of mulch.

Discussion: Due to the size and configuration of the heavy mobile equipment such as a front-end loader, the mobile equipment operator may have a large blind spot area and may not be able to see people walking around the equipment. A driver is at great risk of being run over if he exits his truck during loading and unloading. The hazards related to entering a trailer during loading should also be addressed. These hazards may include entrapment and engulfing and can result in serious injury or death as in this case.

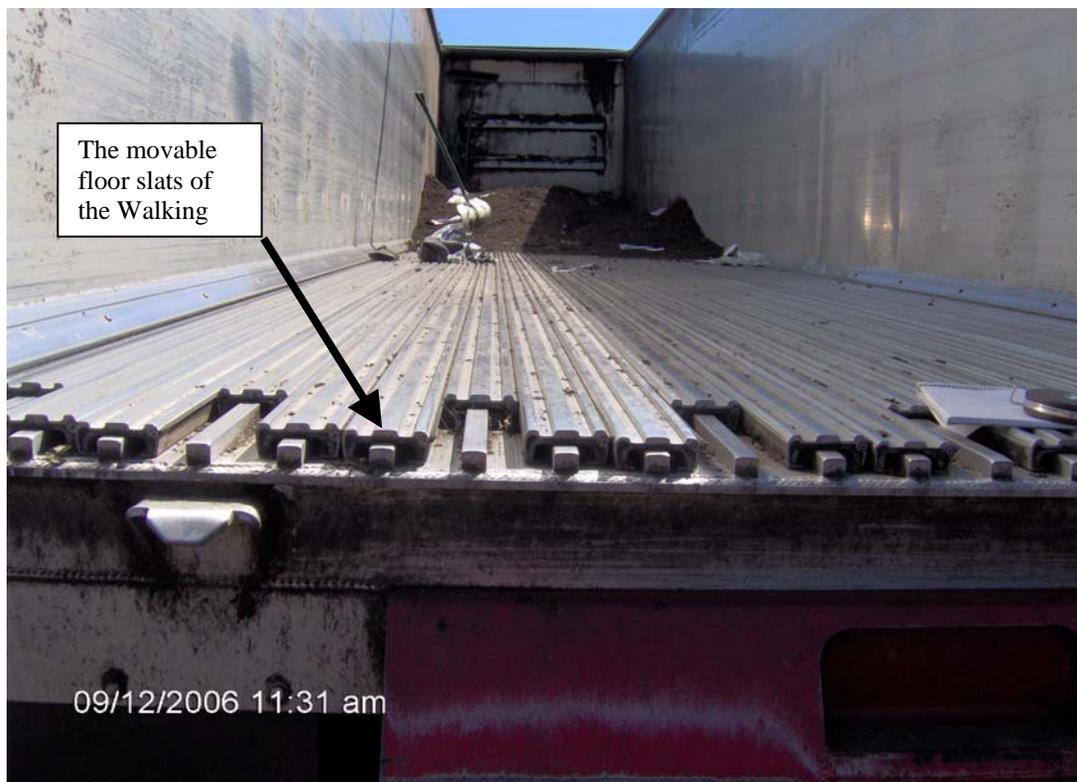
The trailer was equipped with walking floor, an automated unloading mechanism (Photo 3). The walking floor was composed of three groups of narrow movable slats that were powered by hydraulics. The groups of floor slats could move alternately or simultaneously forward and backward. The load was moved during unloading when all floor slats moved simultaneously towards the discharge end. The company reported that drivers usually cover the front trailer wall and a section of the floor before loading. It was believed that the tarp that moved along with the load could keep debris off the floor and reduce manual sweeping after unloading. After the incident, a piece of blue tarp was found buried in the mulch in the trailer. It is believed that the victim may have entered the trailer from the rear to cover the walking floor with the tarp just prior to when the loader operator approached the trailer with the first load of mulch.

Photo 3. The victim's trailer was equipped with a walking floor (photo courtesy of OSHA).

According to the victim's employer, drivers usually covered the front trailer wall and section of the walking floor with a tarp before loading in order to reduce manual sweeping. However, the walking floor manufacturer stated that this practice did not always reduce manual sweeping.

There are different types of floor slats for handling different cargoes: some have relatively smooth surfaces while others have ridges and deep grooves or "valleys". According to the walking floor manufacturer, depending on the types of floor slats and cargo being handled, covering the floor with a tarp may not reduce sweeping. In this case, the victim's trailer had the floor slats with deep grooves. The tarp would not have prevented the debris from depositing in the grooves. However, if the walking floor in this case were composed of smooth slats, the tarp would have kept the debris off the floor and therefore reduced the sweeping.

An automated tarp system with controls on the exterior of the trailer is available through walking floor manufacturers and dealers. The system allows the driver to position the tarp without entering the trailer. Employers should consult with manufacturers or dealers to select appropriate floor slats and

determine the proper cleaning methods. Should a tarp be used, employers should consider installing the automated tarp system.
