FATALITY ASSESSMENT AND CONTROL EVALUATION

Operator of a Trailer Tipper Fatally Struck by a Tractor Trailer at a Landfill Case Report 16NY009

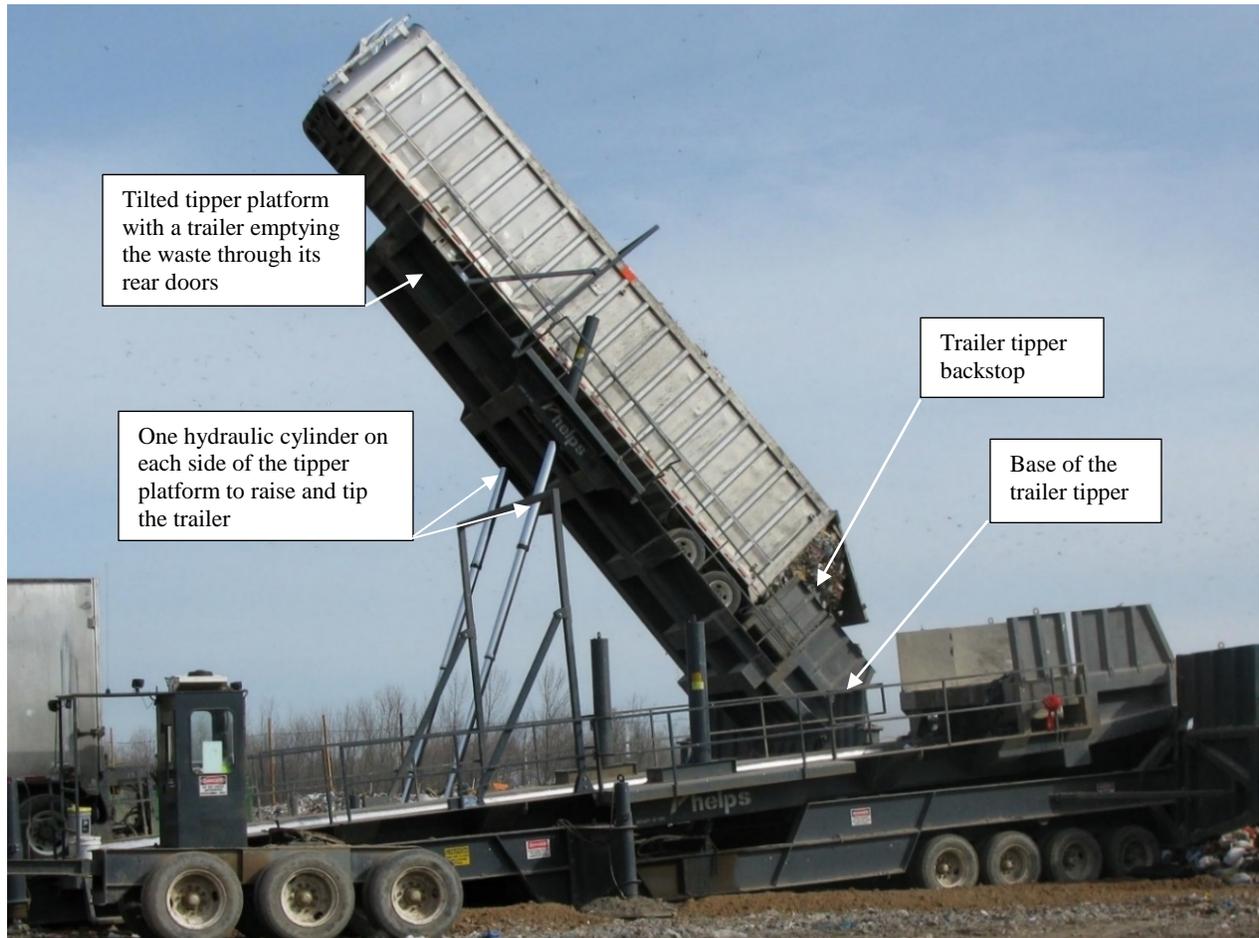
Photo 1. A landfill trailer tipper is tipping a trailer and emptying the waste through the trailer's rear gate by gravity.

At the time of the incident, the victim was operating a trailer tipper at a "working face" where waste was received, deposited, and compacted. A trailer tipper is a device that raises and tips a trailer and empties the trailer by gravity (Photo 1). The essential part of a trailer tipper is a movable platform that can be raised and tilted by hydraulic power. In this case, the tipper platform was 9 feet wide and 40 feet long and could hold a standard trailer. It was hinged at one end and had one 4-stage hydraulic cylinder on each side. The tipper's hydraulic system was powered by a 100-horsepower diesel engine. The tipper cylinders could raise and tilt the deck to over 60 degrees and empty the trailer through its rear doors by gravity.

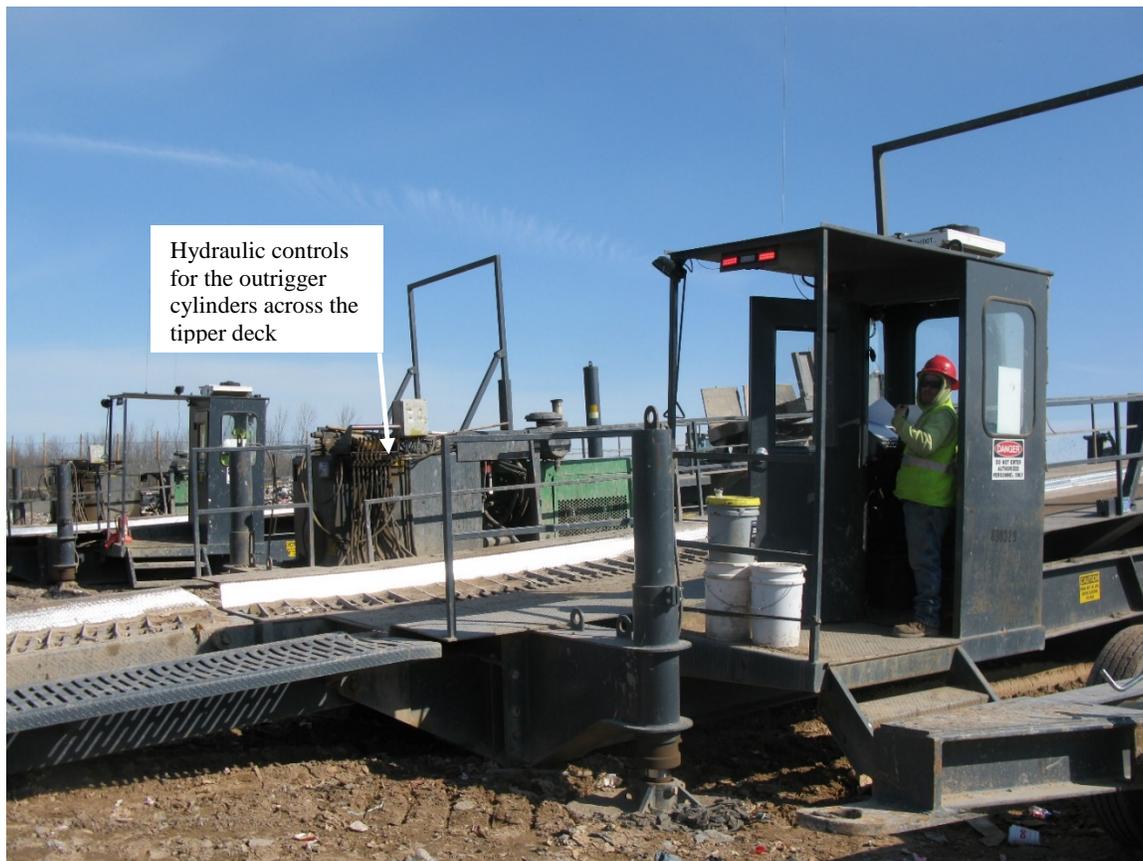
The base of the tipper had metal railings on both sides and a backstop at the hinged end of the movable platform. To get on the tipper, a tractor trailer had to back onto the platform with its rear trailer doors facing the hinged end until it hits the backstop. The tipper had six outrigger cylinders to support and level the structure. The hydraulic controls for the outrigger cylinders were at the left side of the deck when facing the hinged end (Photo 2). The operator only needed to operate the outrigger cylinders when setting up the tipper. There was an operator's cab at the right side of the deck and all the tipper controls along with a CB radio were inside the cab (Photo 3). An operator could only hear the CB radio

Photo 2. Hydraulic controls for the outrigger cylinders were on the left side of the deck and the operator's cab was on the right side.

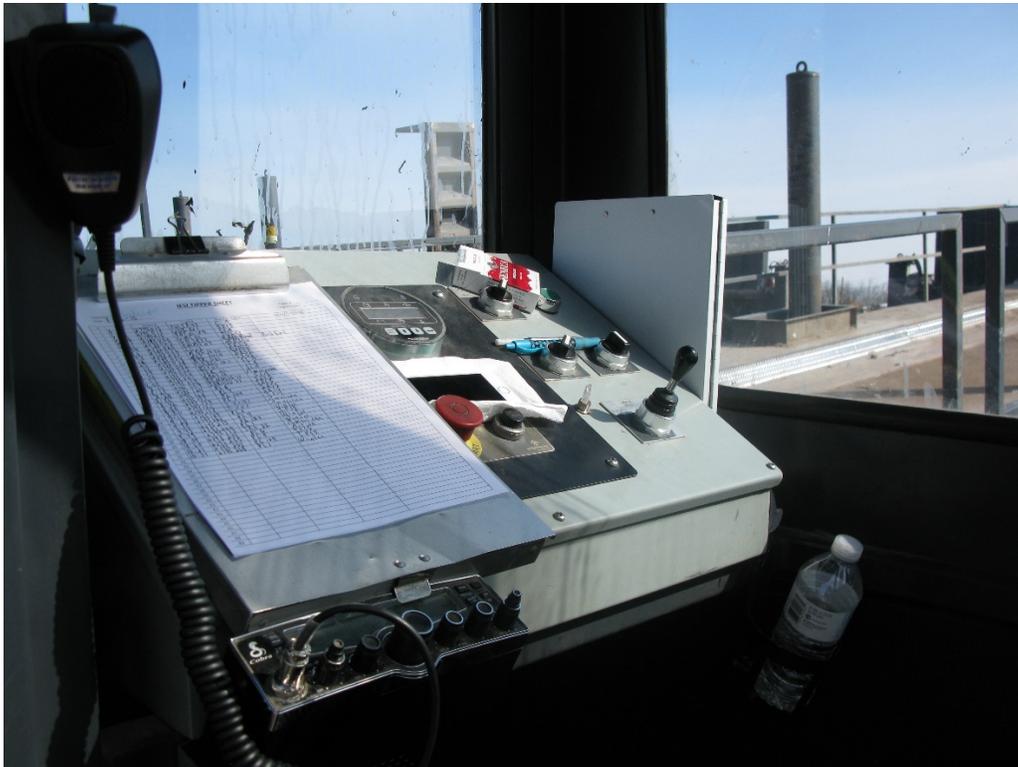
when he was inside the cab. There was no radio communication for a tipper operator once he left the cab and was out on the tipper deck.

Photo 3. Tipper control panel and a CB radio inside the operator's cab.

Discussion: The bulldozer operator in this case tried to warn the victim when he saw the “army truck” trailer backing up, but he could not reach the victim since the CB radio was inside the operator’s cab and the victim was on the deck. Landfill employers should provide a secondary communication method such as a walkie-talkie for the working face staff to communicate with the equipment operators and other pedestrian workers. The operators should be required to always carry the walkie-talkie when they are outside the operator’s cab.

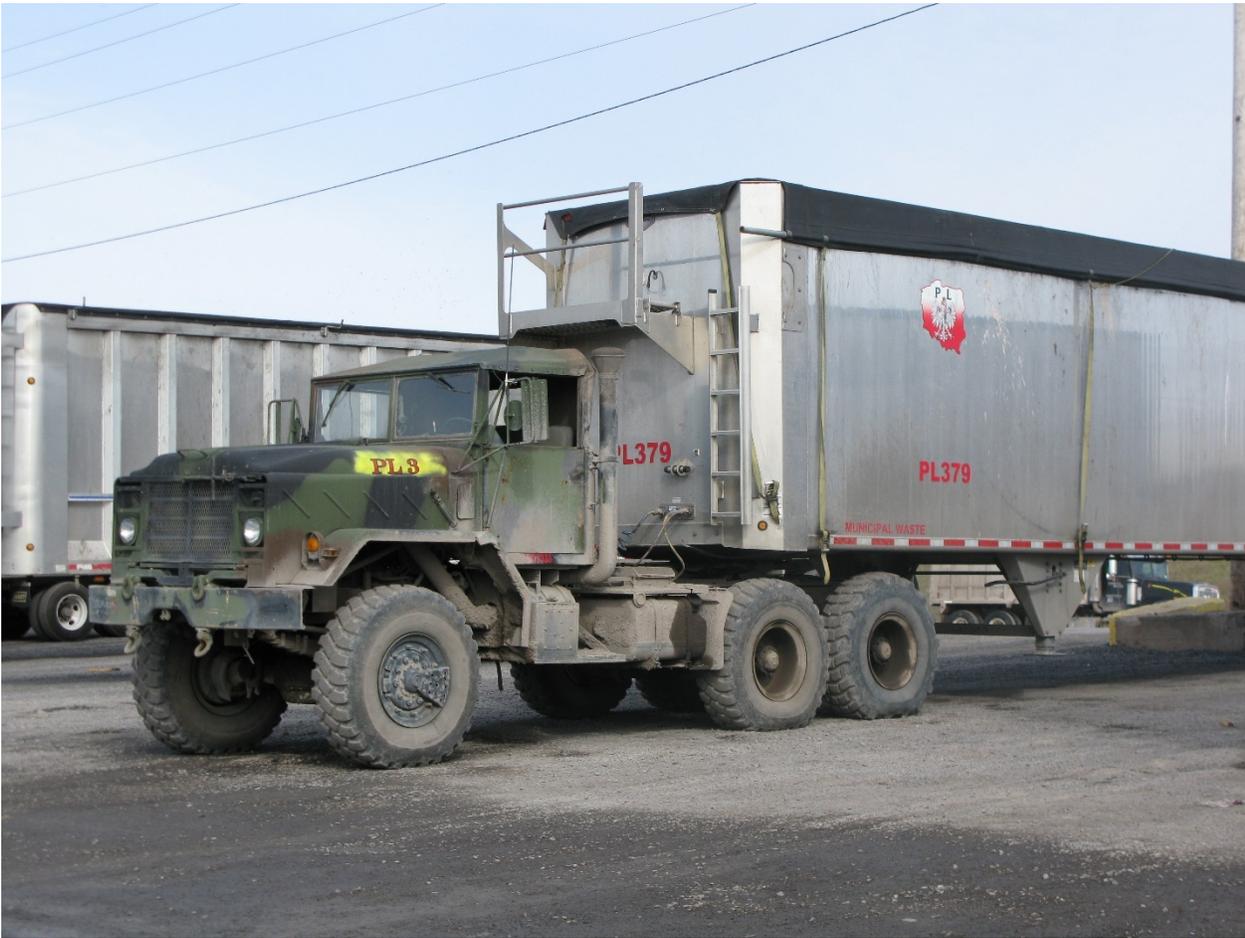
Photo 4. A military surplus tractor (“army truck”) was used to haul the trailer and deposit waste in the landfill.

The “army trucks” did not have audible backup alarms, although the mirrors on the trucks worked. The tractor radios did not work most of the time due to the incompatible electrical voltages between the tractor and the radio. The “army truck” drivers reportedly often drove up to a working face and backed up to a tipper whenever they saw that the tipper was empty without getting the radio communication from a tipper operator.

Discussion: In this case, the only available communication method between the tipper operator and a delivery driver was through a CB radio. The radios on the “army trucks” did not work and the trucks’ backup alarms were broken. Landfill employers should require that all visiting vehicles have radios and backup alarms that are working properly. Vehicles without working radios and backup alarms should not be permitted to enter the landfill.

Discussion: The solid waste trucking company in this case purchased the "army trucks" that did not have working radios and backup alarms. The radio communication was critical at a working face to ensure the safety of the landfill operators and the delivery drivers. Trucking companies should make sure that the waste tractor trailers have all the required safety features and communication devices required by the landfill. Trucking companies should provide training to their drivers to ensure that they follow the landfill safety procedures and policies when depositing wastes at the landfill.

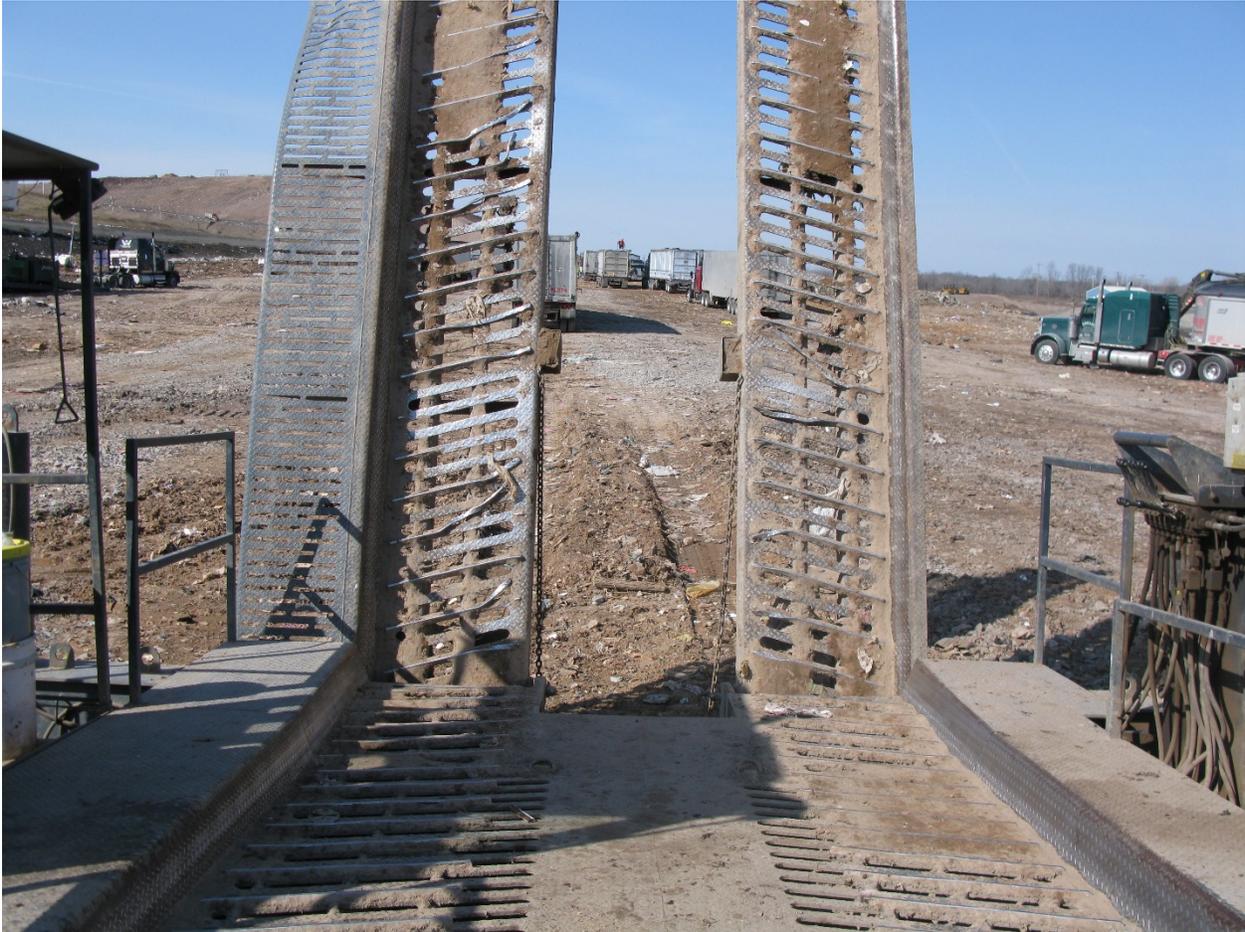
Photo 5. The access ramp is raised to stop the tractor trailer from backing onto the tipper deck when operator is outside the operator's cab.

After the incident, the landfill began requiring that the tipper operator raise and tilt the metal access ramp to stop tractor trailers from backing onto the tipper deck every time a tipper operator is outside the operator's cab and on the deck (photo 5).

- Set up a physical barrier to block the deck;
- Radio all delivery drivers at the working face that the deck is closed;
- Use a visual signal such as a flashing red light to show that the deck is closed;
- Coordinate with other landfill vehicles such as bulldozers to block the path to tipper deck.
