## FATALITY ASSESSMENT AND CONTROL EVALUATION

### Worker Crushed Unloading Steel Waste Container Case Report 16NY066

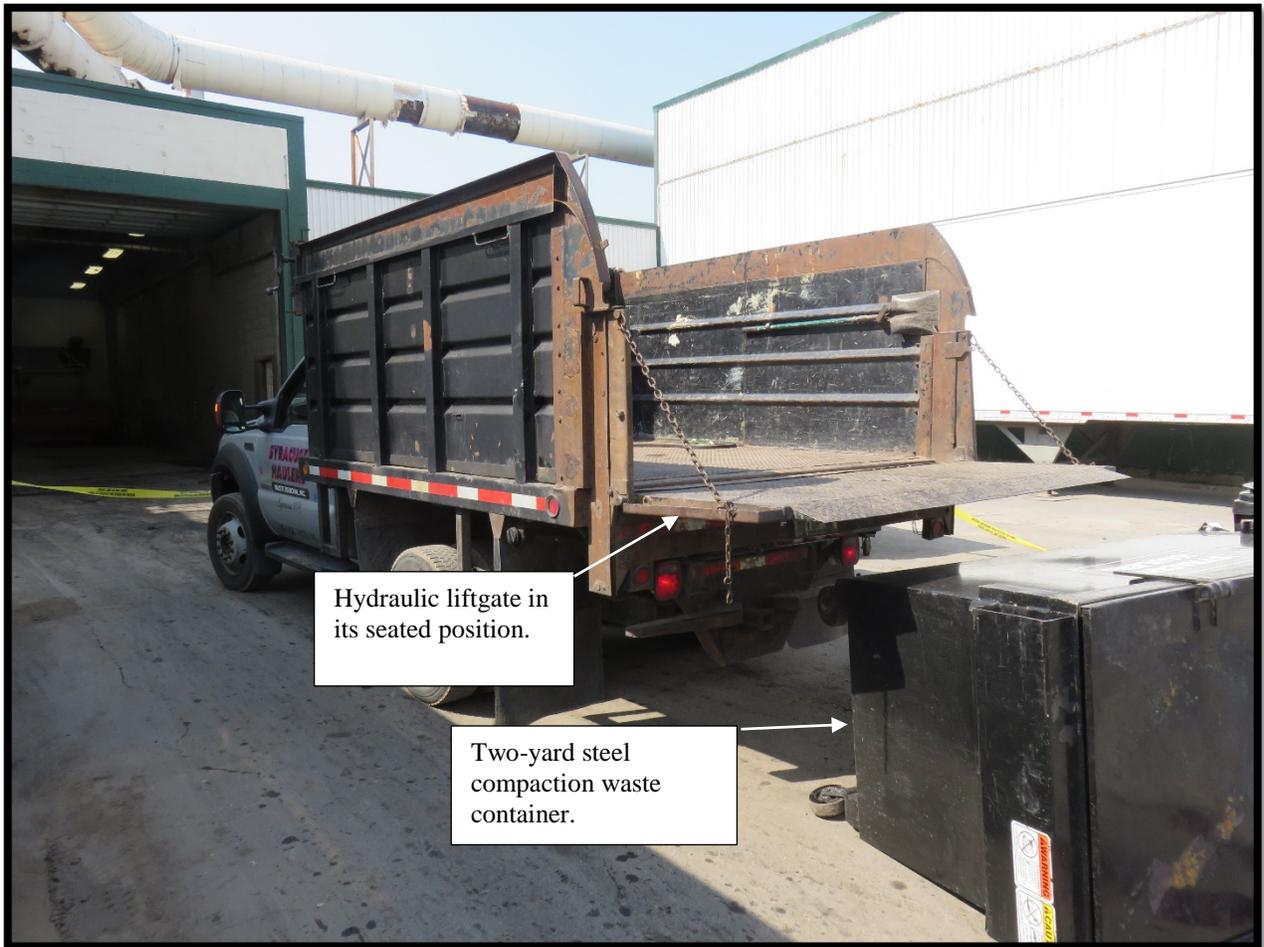
On May 25, 2016, a 58-year-old shop supervisor (victim) at a waste management company was fatally crushed while unloading a 2-yard steel container that weighed 900 Lb. from the back of a truck with an attached hydraulic liftgate (Photo 1). The New York State Fatality Assessment and Control Evaluation (NY FACE) staff learned of the incident from the news media and contacted the employer to initiate an investigation. The company declined to participate in the NY FACE investigation. The Occupational Safety and Health Administration (OSHA) and the city police department investigated the case. The NY FACE investigator discussed the case with the OSHA compliance officer and reviewed the OSHA and police reports and the death certificate. This report was developed based on the information provided by OSHA and the city police department.

*Photo 1. The truck with hydraulic liftgate being used to load and unload containers and the container after falling from the liftgate. (Photo courtesy of OSHA)*

On the day of the incident, the driver was bringing the empty container to the wash bay in the back of a Ford 550 dump truck that was equipped with a Tommy Gate hydraulic liftgate attached to the rear of the vehicle (Photo 1). The weight capacity of the liftgate was not available for the investigation, but it is not believed to be a factor in the incident. The width of the liftgate allowed for 12 inches of space on either side of the container if centered. The liftgate was 28 inches deep to the beginning of the bevel which was an additional six inches. The center point of the casters on the container came to the edge of

**Recommendation #1:** *Employers should establish a written procedure that specifies safe work practices to safely handle, load, and unload containers. Employers should provide a forklift or a truck that is compatible with the loading dock to safely load and unload containers that are too large and heavy to be handled by a truck liftgate.*

**Recommendation #3:** *Employers should ensure that containers are secured to the liftgate during loading and unloading so that they would not fall off the platform and cause worker injury.*

**Discussion:** The 900 Lb. waste container with casters was neither strapped nor chocked in this case. Employers should ensure that large, heavy, and unstable containers are restrained and strapped securely to the liftgate. Wheeled containers such as the one in this case should be both strapped and chocked to prevent them from tipping and rolling of the liftgate platform causing worker injury and death.

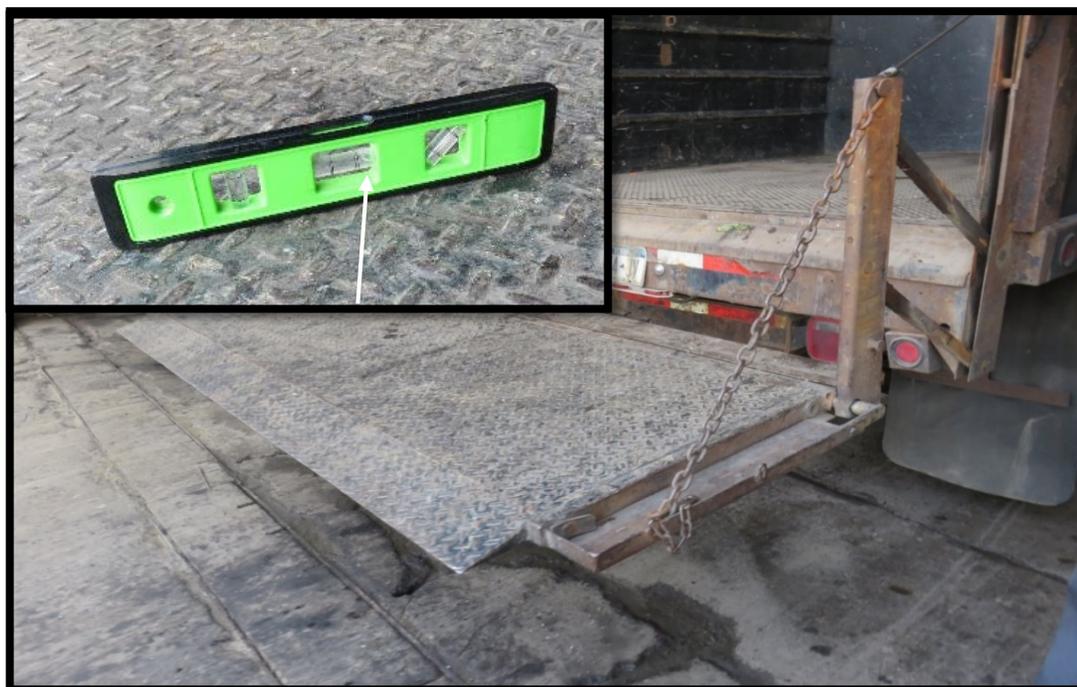
the bevel leaving no room for any front to back movement during descent. The liftgate on the truck was known to pitch downward as it lowered from its seated position. During the investigation, the pitch of the liftgate was measured at an angle of 9.5 degrees when lowered (Photo 2). With the casters resting on the edge of the bevel and the downward pitch of the liftgate, the container was at risk of rolling off the liftgate during unloading. In its seated position, the liftgate was measured at a height of 47.5 inches. The wash bay did have a loading dock that could be used to unload containers. However, the bed of the truck was not high enough to line up with the loading dock. Employees would either use a forklift or manually unload the container.

*Photo 2. The hydraulic liftgate in a lowered position. A level showing the downward pitch of the liftgate. The downward pitch was measured at an angle of 9.5 degrees. (Photo courtesy of OSHA)*

**Recommendation #4:** *Employers should implement a regular liftgate preventative maintenance schedule according to manufacturer specifications.*

**Discussion:** According to the owner's manual, the liftgate needed to be serviced every 60 days. A preventative maintenance program must be followed in order to keep the liftgate in its best and safe operating condition. If there are any noticeable problems with the liftgate, such as a platform pitching downward, it should be taken out of service and repaired immediately.

**Recommendation #7:** *Employers should consider installing additional liftgate safety features to reduce risk factors and make the equipment safer to operate.*

**Discussion:** Manufacturers have developed features and mechanisms that make a liftgate safer to operate. A remote control allows a worker to operate the liftgate outside the cargo falling zone. Self-leveling liftgates can keep the platform level and liftgate cart-stops can prevent cargo from rolling off the platform. Employers should consider installing and utilizing these liftgate safety features to enhance the equipment safety so that workers can be better protected.

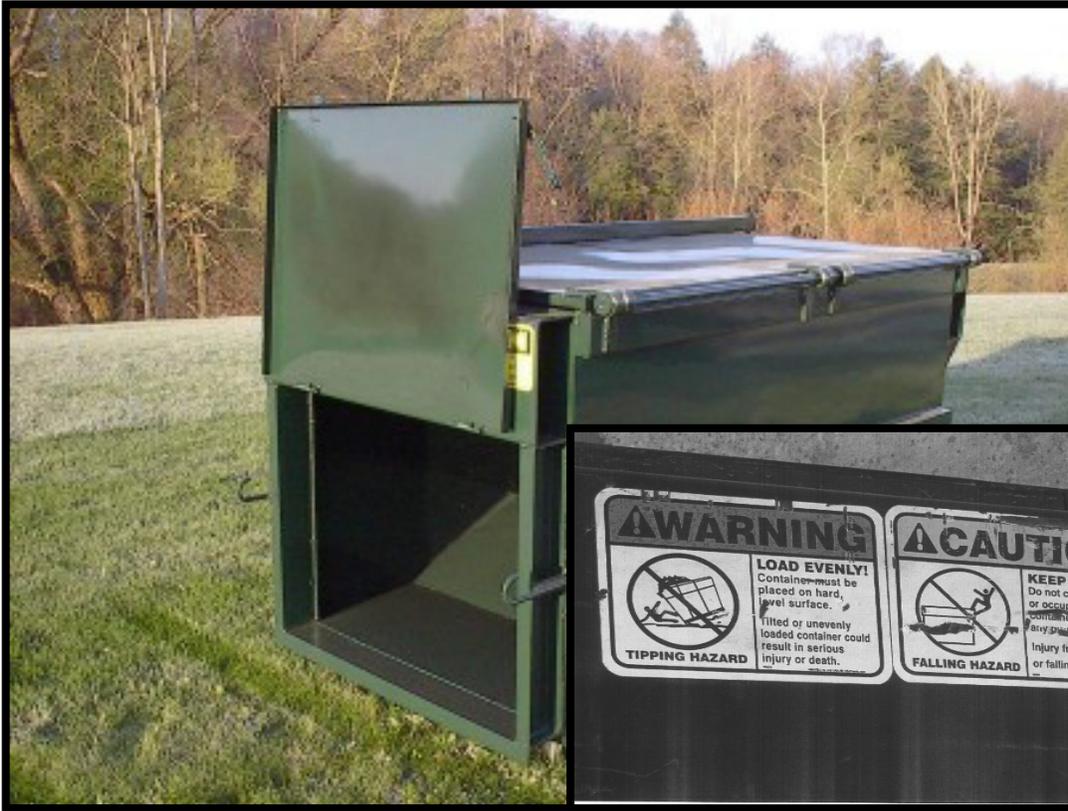
The container in this incident was a two-yard metal compacting container that rested on a set of four caster wheels. Empty, this container weighs approximately 860 pounds plus ten pounds for each caster resulting in a total of 900 pounds. The dimensions of the container measure 50.5 inches high on its castings, 76.25 inches wide, and 36 inches deep. The manufacturer warned of tipping and crushing hazards associated with this container (Photo 3).

Photo 3. The two-yard steel compactor container and warning labels depicting crushing hazard. (Photo courtesy of OSHA)
