## **FATALITY ASSESSMENT AND CONTROL EVALUATION**

### **Tower Technician Killed When Guyed Tower Collapsed Case Report 09NY095**

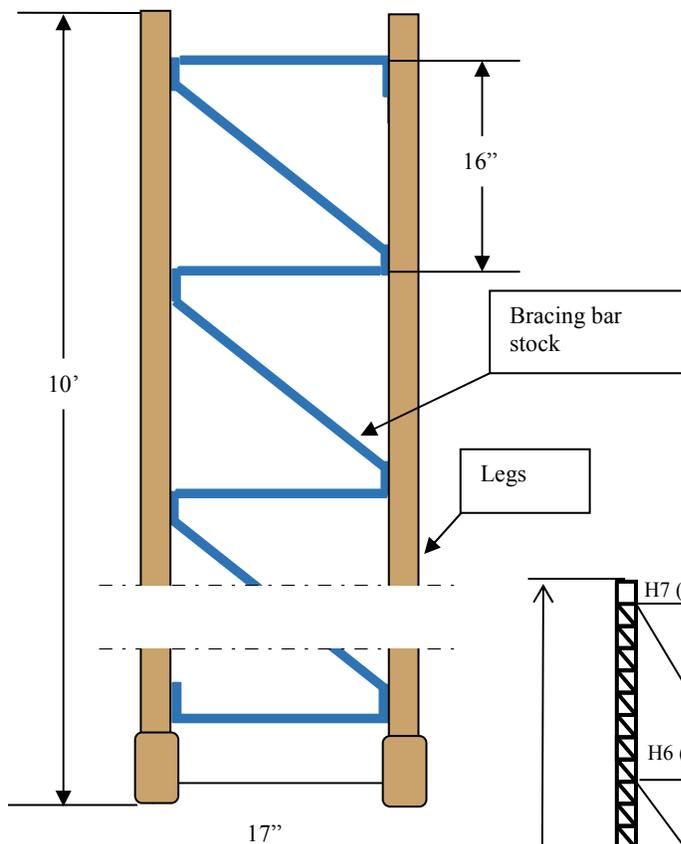
Figure 1\*. A section of the tower

The tower was a 380 foot tall equilateral triangle column with 17 inches on each side (Figures 1 and 2). The tower column was formed by multiple 10-foot-long sections connected by friction fits with two bolts and nuts per connection. Each section was made of three vertical steel pipes or legs that were braced with round steel bars into the triangular column. The steel pipes were 1.5 inch in (outside) diameter and 0.12 inch thick. Round steel bars that were 7/16 inch in diameter braced the three legs in a continuous zigzag pattern.
